Evaluation of a Korea Produced Yellow Film

Project #: 05-230-1125

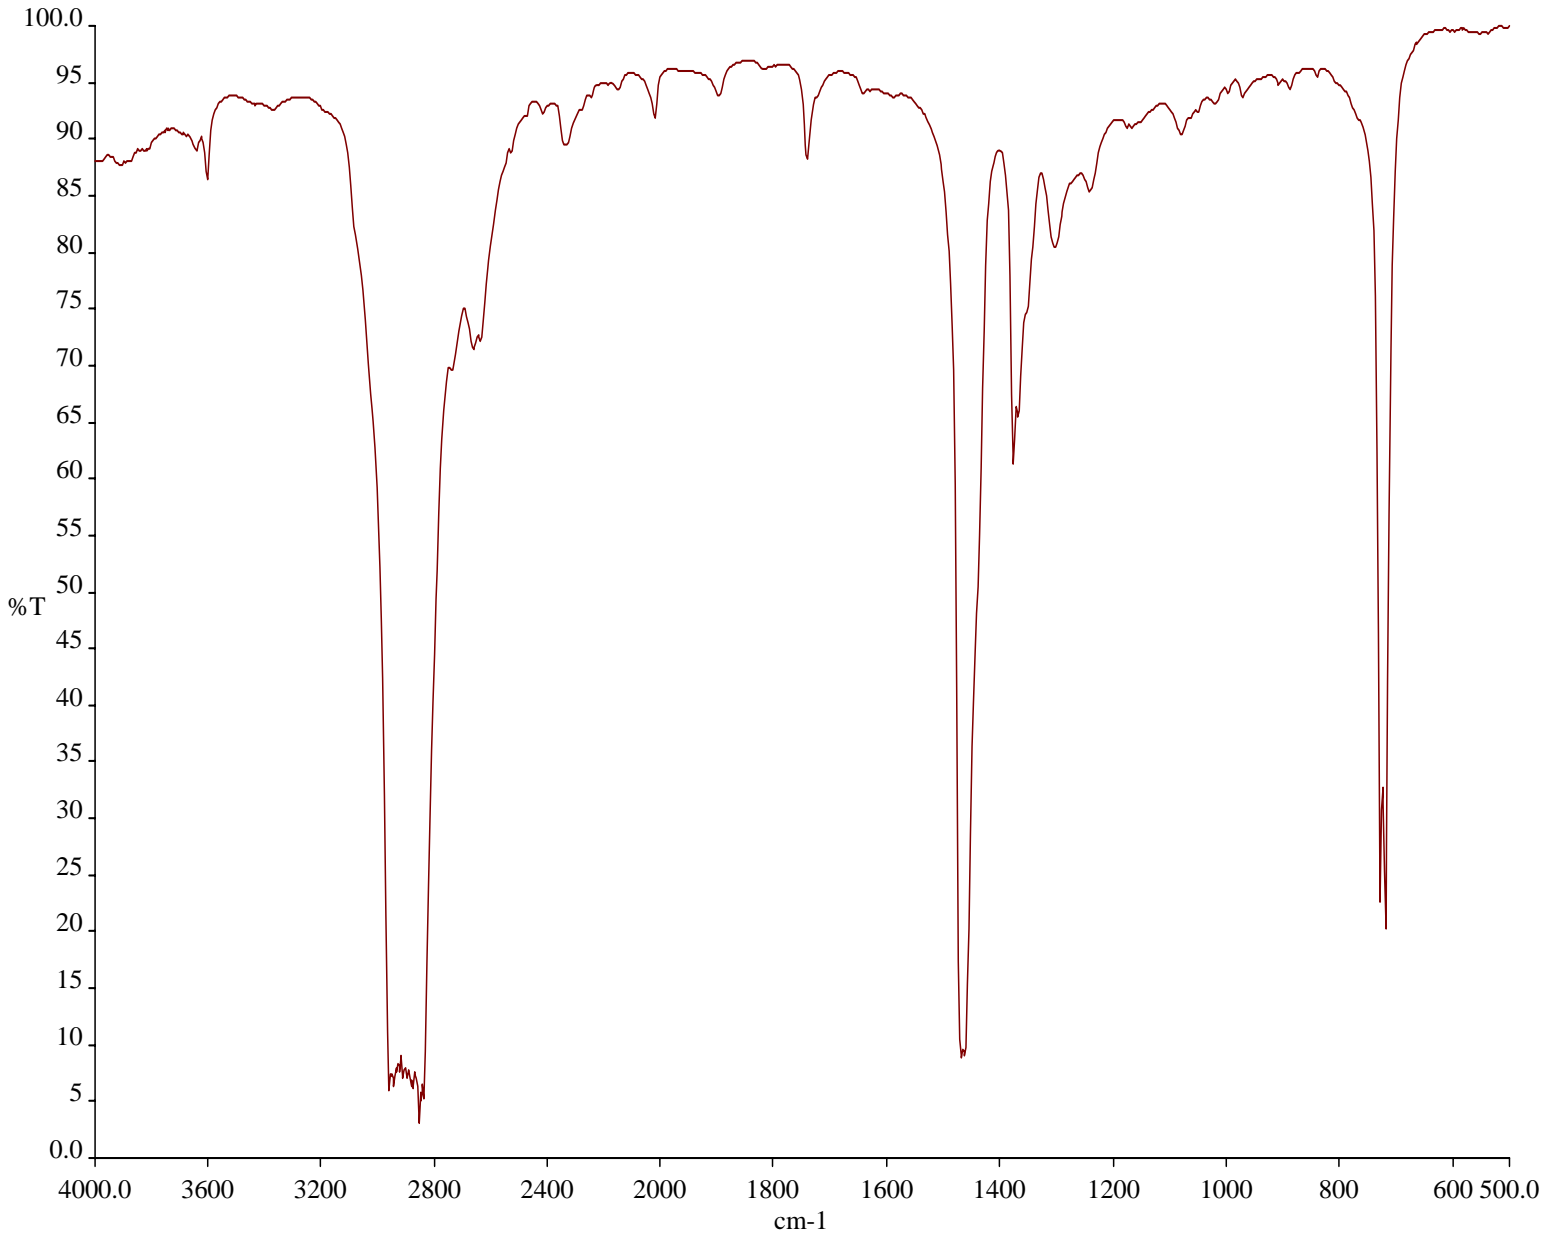
FT-IR Analysis

Conclusion: Based on the above results, the Korean produced yellow film fails to provide sufficient contact, barrier and vapor phase corrosion inhibition. Based on the FT-IR spectra this film doesn't contain sufficient amount, if any, of corrosion inhibitors, including VpCIs.
