***Armor Blue Shrink Poly Film with UV Compared to VpCI-126
HPUV-Part 2 Comparing UV Protection***

Project #: 14-023-1125-Part 2.bis

Date: July 15, 2014

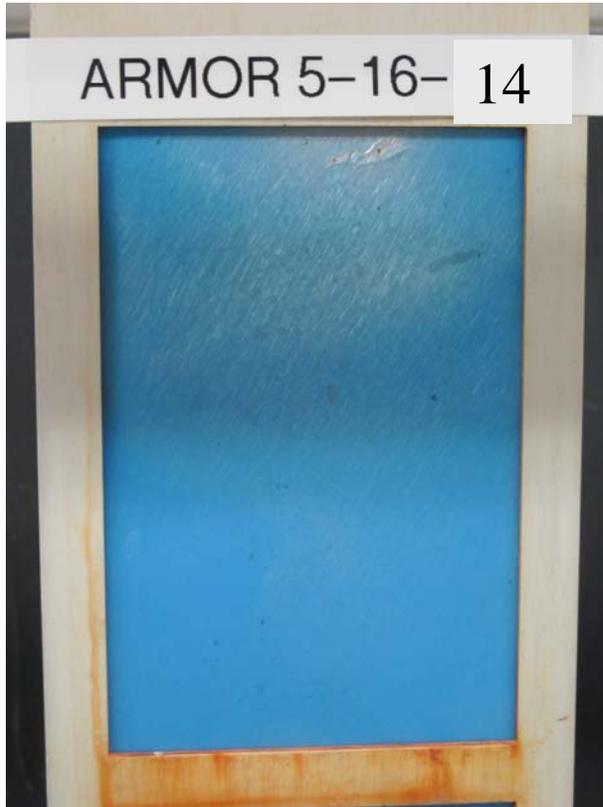
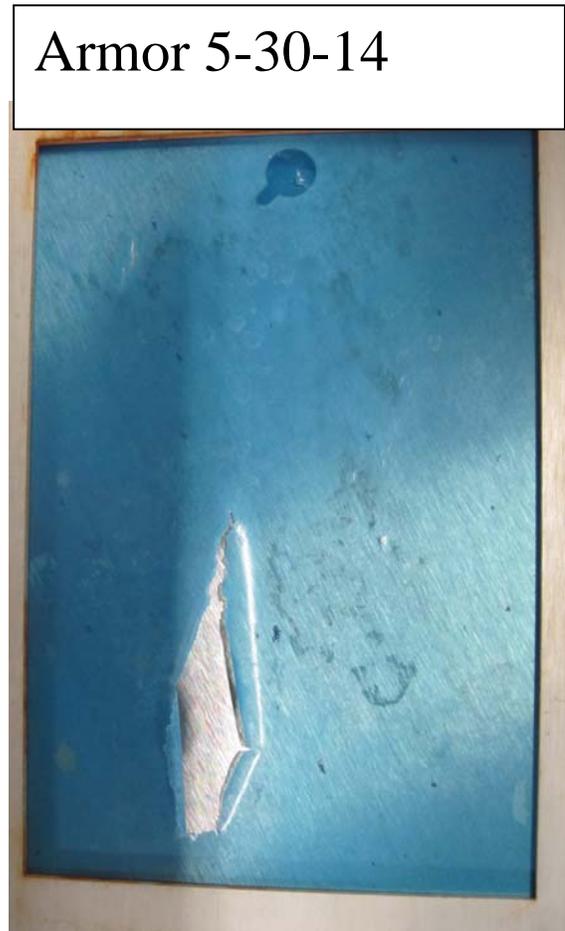
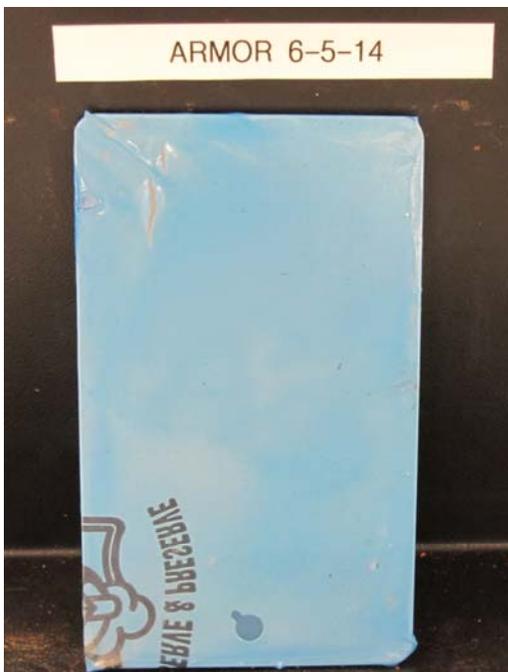
Figure 1. The 3 pictures above were taken the date that the Armor films failed; the corresponding date of the failure is listed above each panel.

1. Based on test results, VpCI-126 HPUV provides better UV protection than Armor Poly VCI film.
2. The Armor film started cracking and breaking down after 85-104 days in the UV chamber (figure 1) compared to VpCI-126 HPUV, which has not shown any signs of failure after 145 days (figure 2).

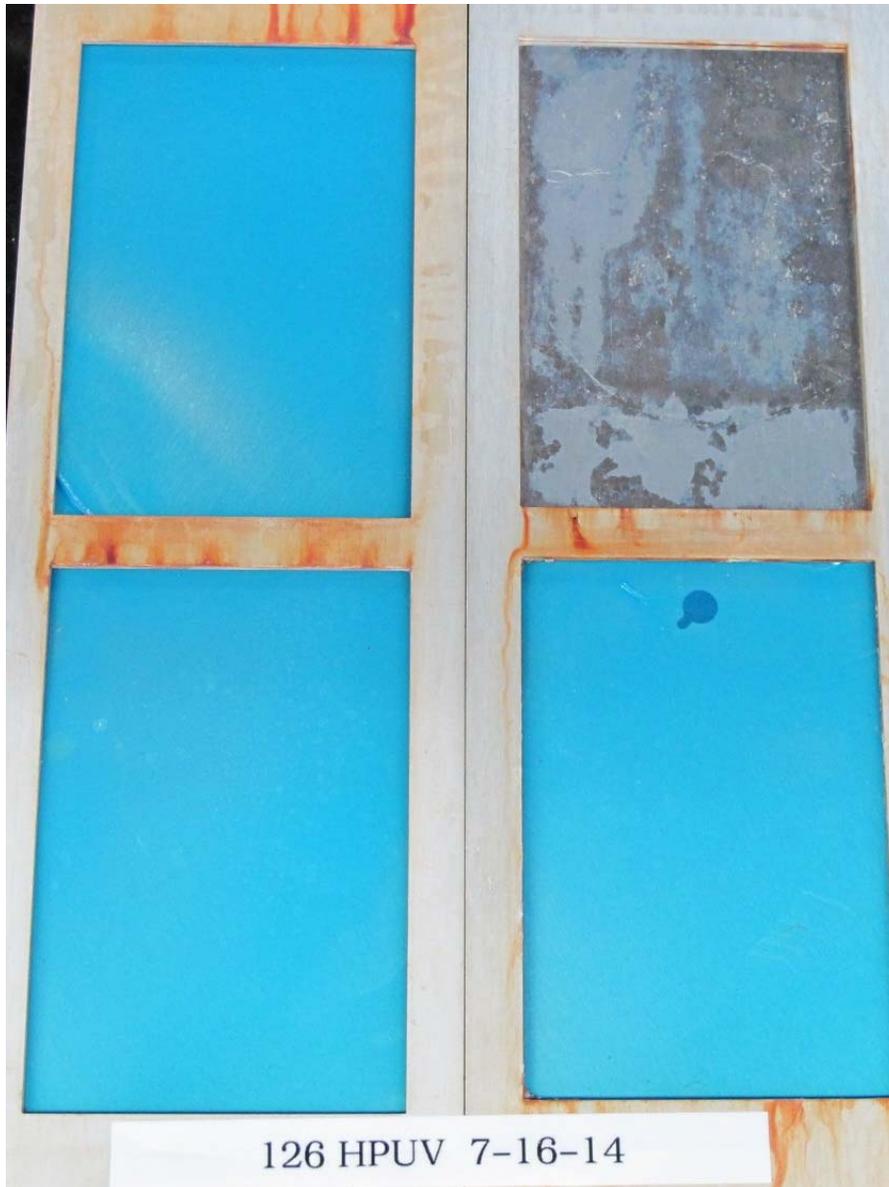
Figure 2. VpCI-126 HPUV film 145 days after the films started in the UV chamber, and there are still no signs of the film degrading. The panel in the upper right is a control.
