## *Evaluation of Cortec products for Cummins*

**Purpose:** Evaluate the effectiveness of Cortec VpCI film and surface preparation products in protecting the engine components from corrosion in an accelerated corrosion test.

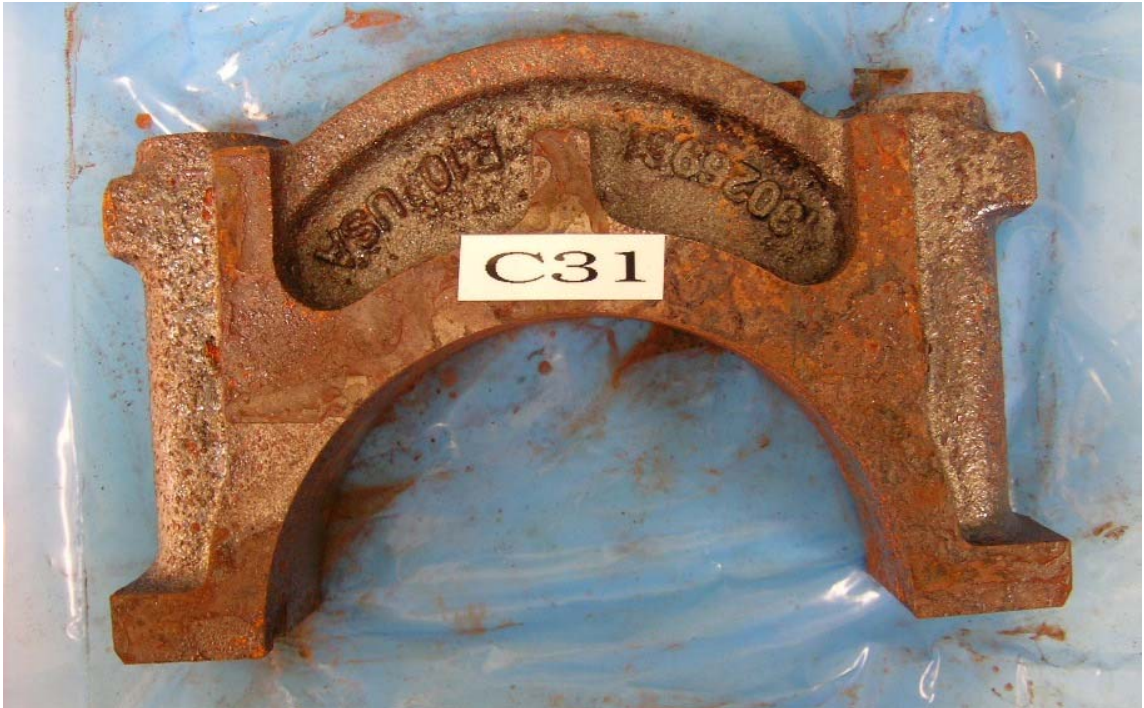
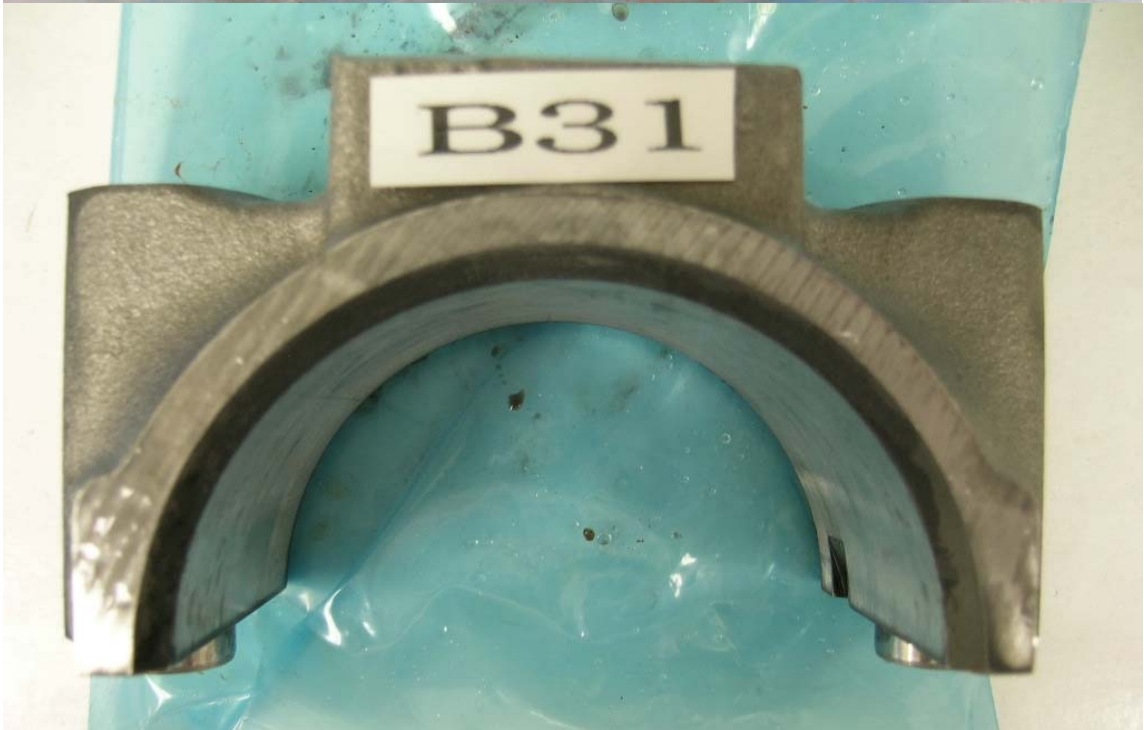
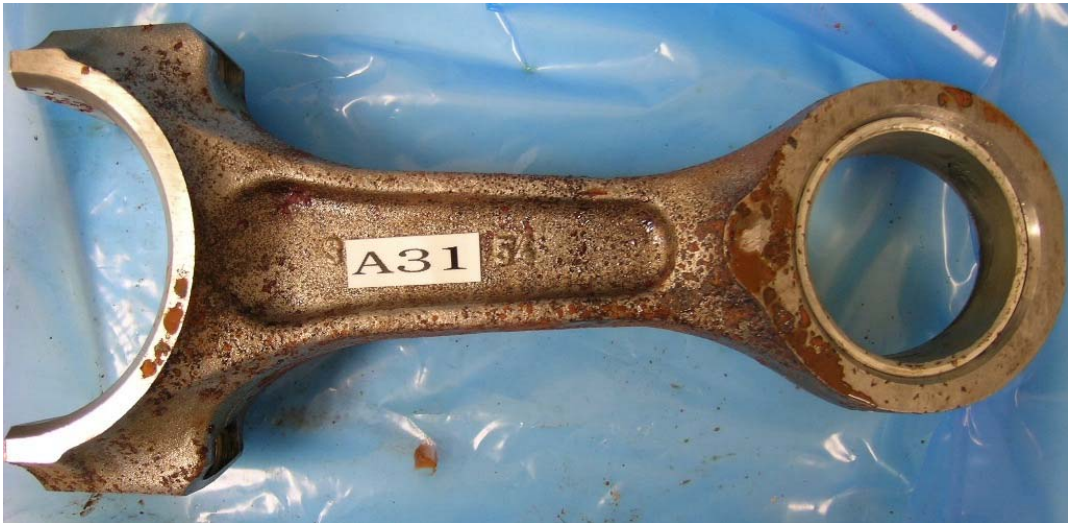
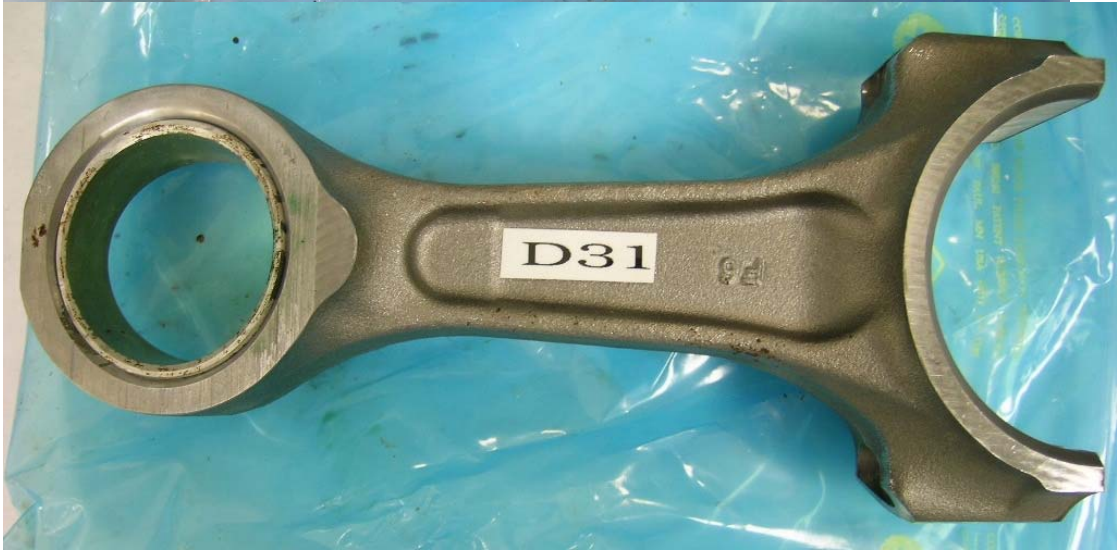
Sample	Time to Failure (hours)
A31	100
B31	Did not Fail
C31	131
D31	Did not Fail

**Conclusion:** VpCI-126 Blue film provided superior corrosion protection to the piston rods when compared to the Armor VCI blue bag. The VpCI-418LM easily cleaned the components and helped protect them from flash rust corrosion before packaging.
