Comparing Cortec Packaging to WD-40 on Parts from Textron Lycoming

Purpose: Evaluate various protection methods for connecting rods from Lycoming Engines.

Project #: 07-237-1825

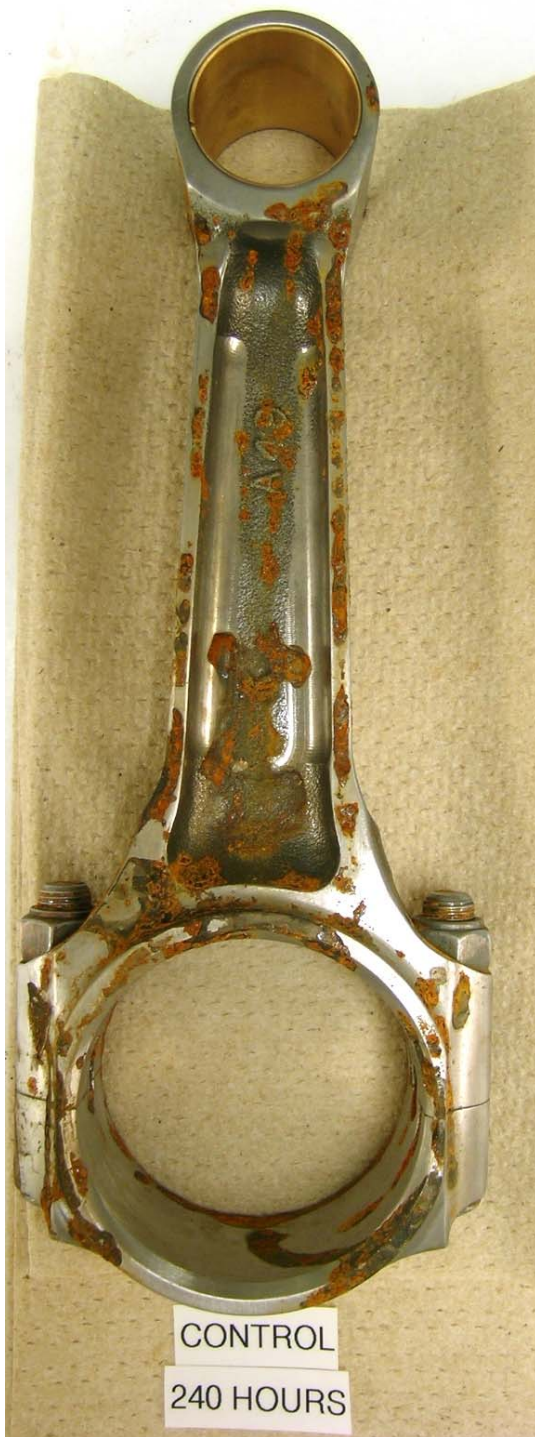
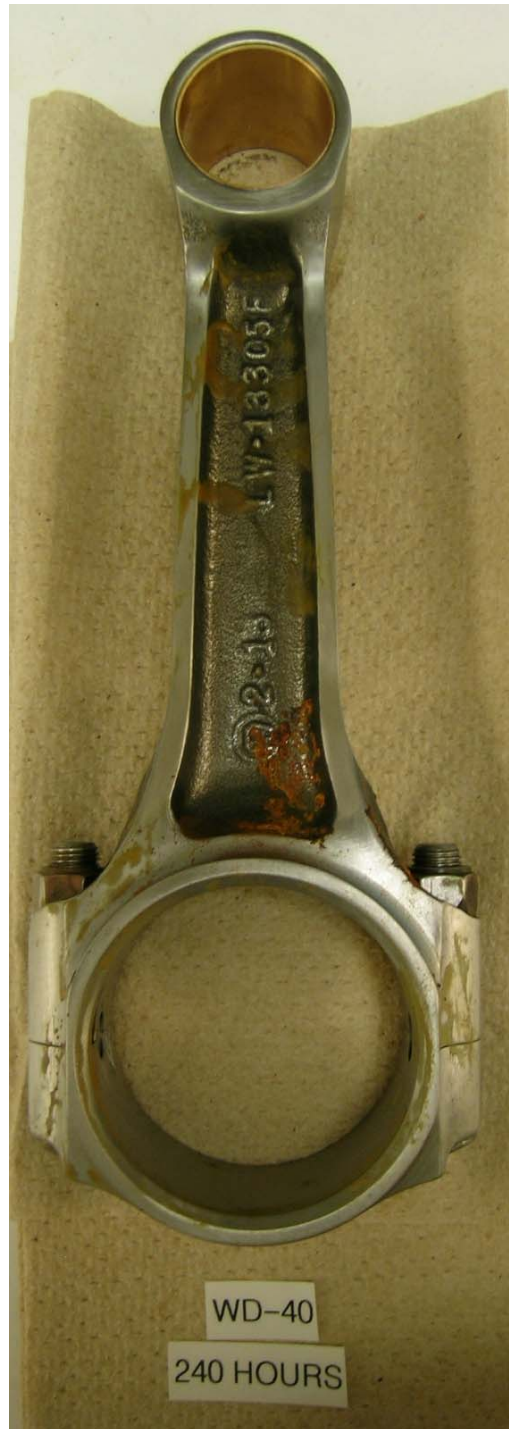
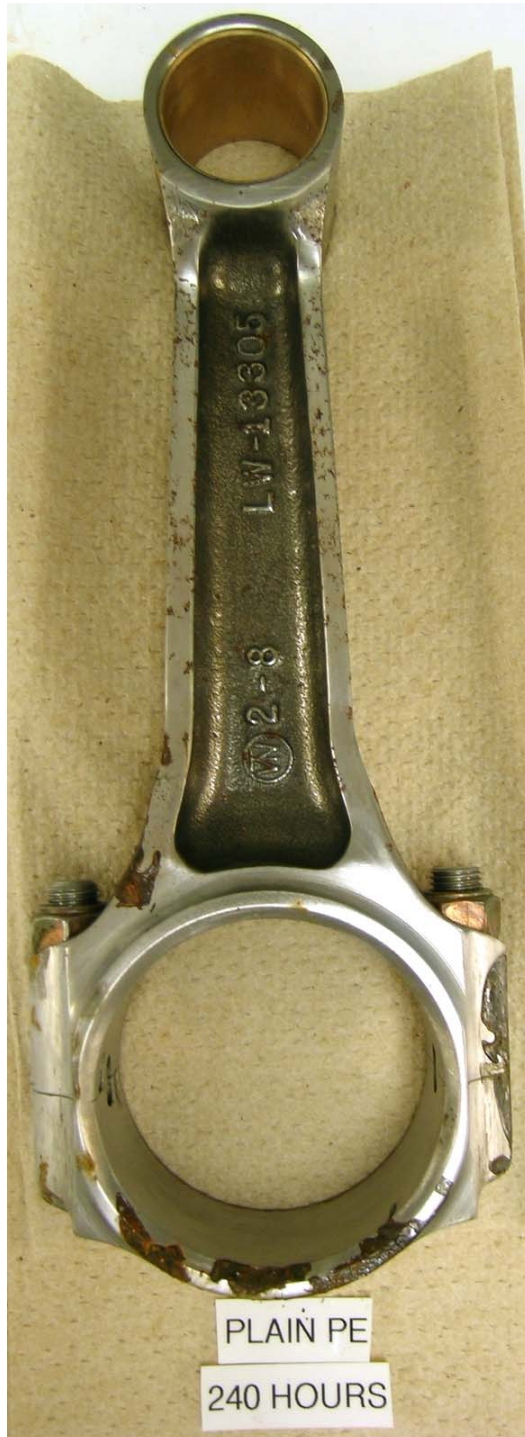
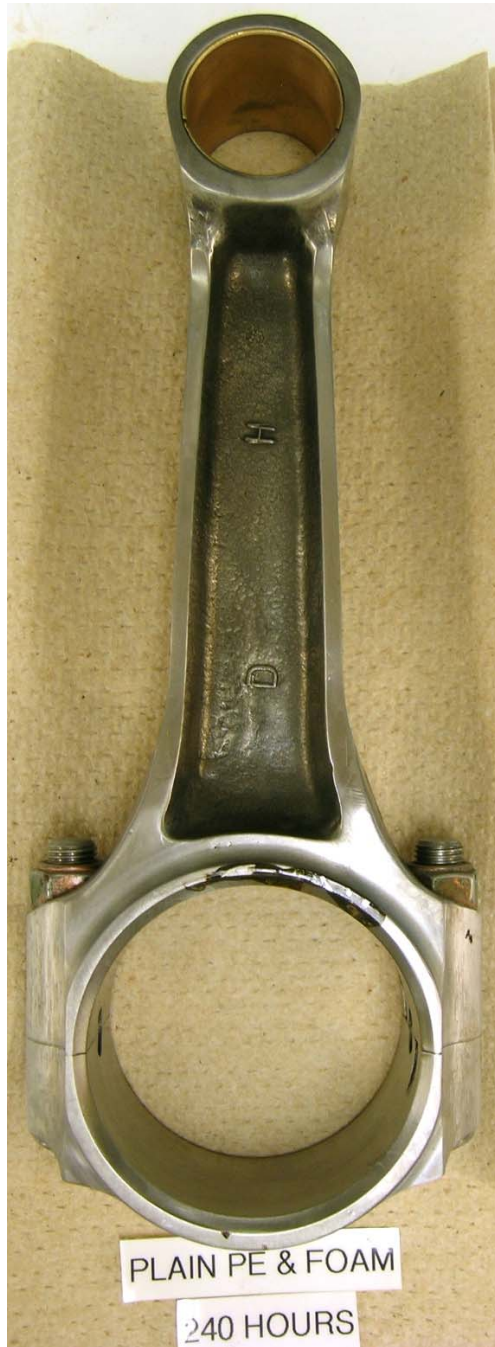
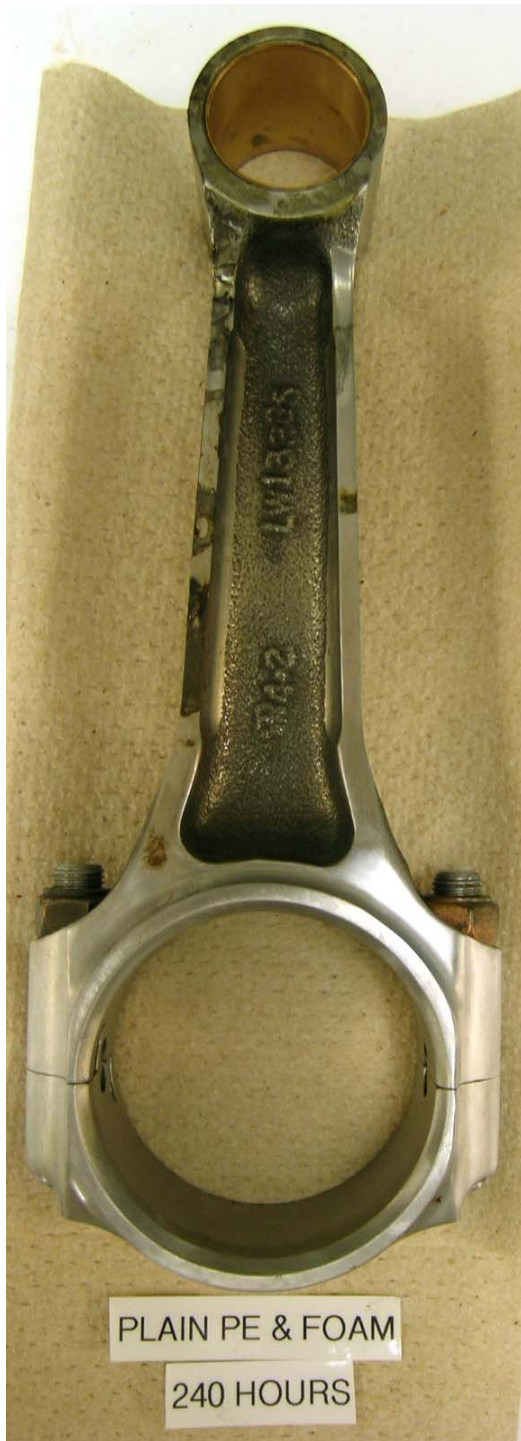
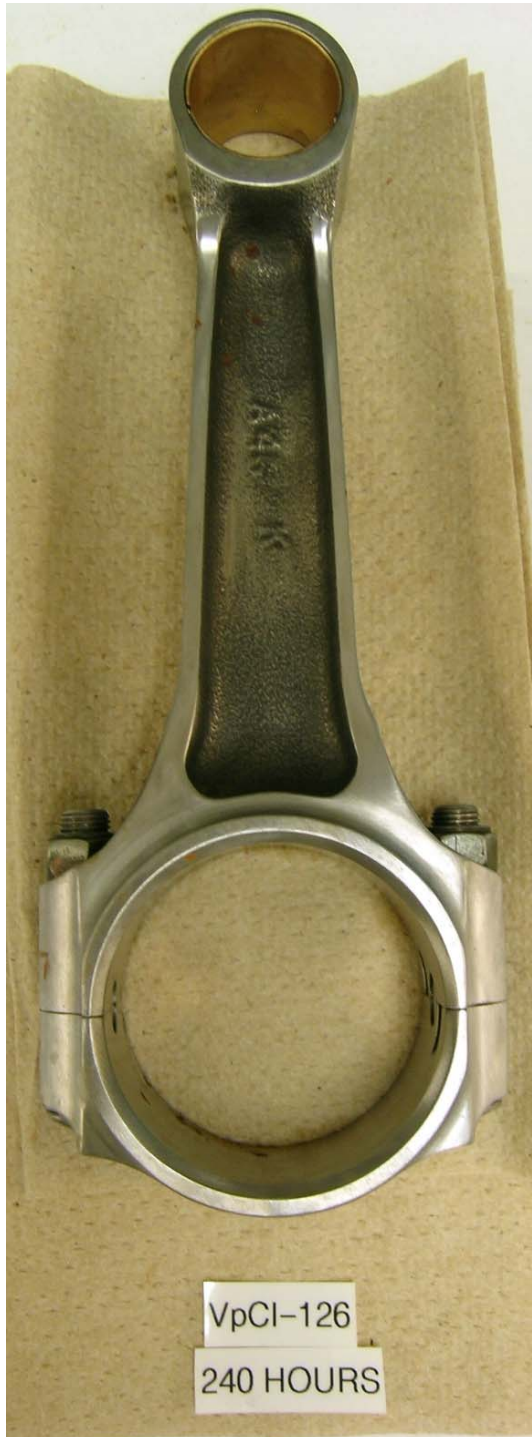
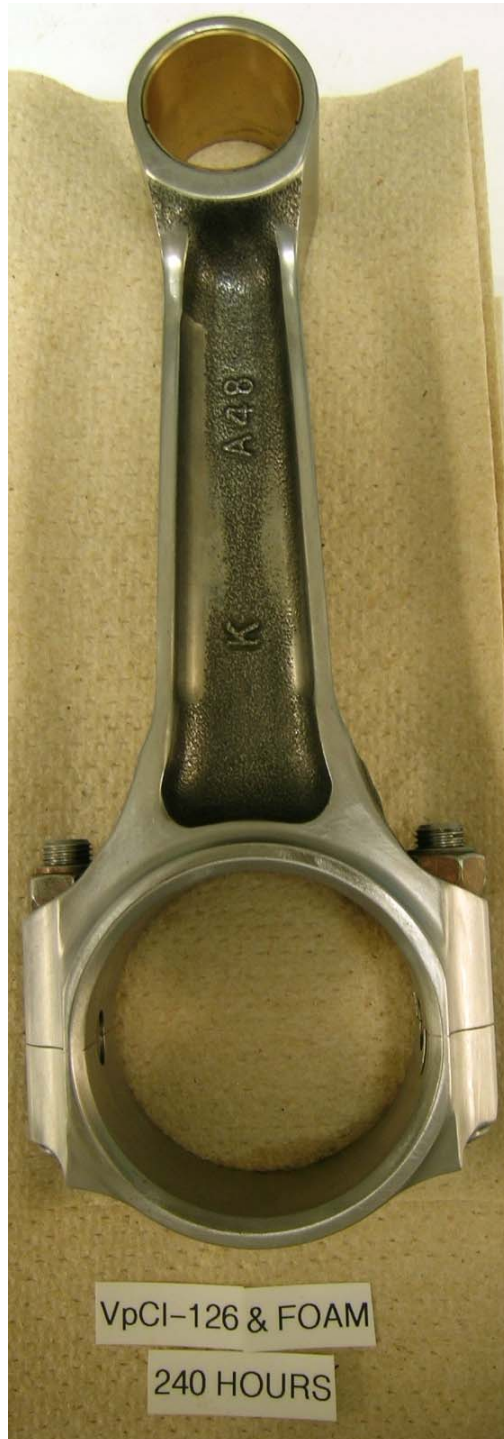
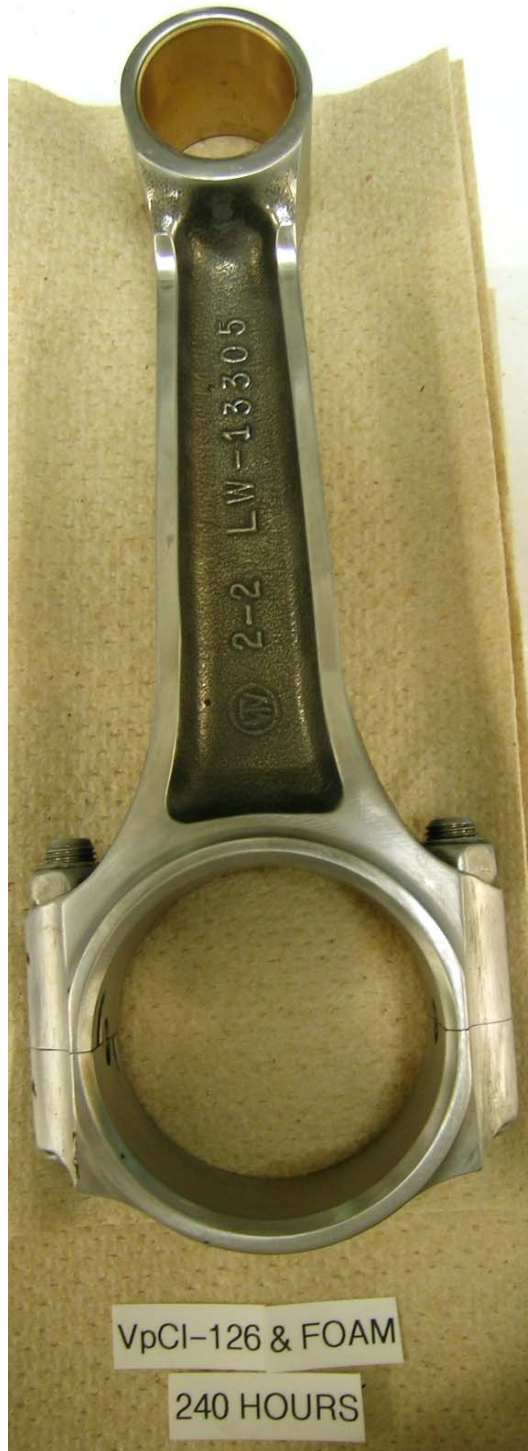
- 1) Control part: After 240 hours in water fog conditions, corrosion was present on ~25% of the surface area of the control part.
- 2) WD-40 part: After 240 hours, corrosion was present on ~10% of the surface area of the part.
- 3) Plain PE part: After 240 hours, corrosion was present on ~25% of the surface area of the part.

- 4) Plain PE with VpCI-131: After 240 hours, corrosion was present on ~5% of the surface area of the parts.
- 5) VpCI-126 bag: After 240 hours, corrosion was present on ~5% of the surface area of the part.
- 6) VpCI-126 with VpCI-131: After 240 hours, corrosion was present on less than 1% of the surface area of the part.

Conclusion: The combination of VpCI-126 and VpCI-131 foam provided the best protection for the connecting rods from Lycoming Engines. The use of VpCI-131 greatly increased protection within the plain PE bag, while the use of VpCI-126 provided excellent protection as well. WD-40 did not provide adequate corrosion protection, and it left an oily surface after testing.
