Comparing VpCI-325 to Mobilarma Product

Project #: 08-230-1125(bis)

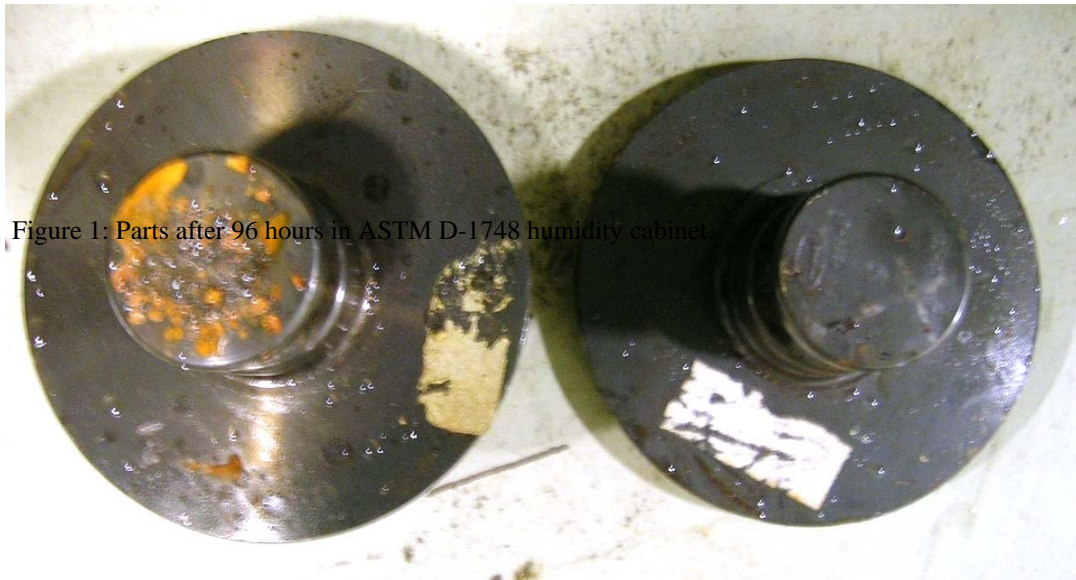
Figure 1: Parts after 96 hours in ASTM D-1748 humidity cabinet.

- 1) The first part, coated with the submitted Mobilarma product, showed significant corrosion after 96 hours in humidity testing. After 336 hours, corrosion covered ~10% of the surface area of the part.

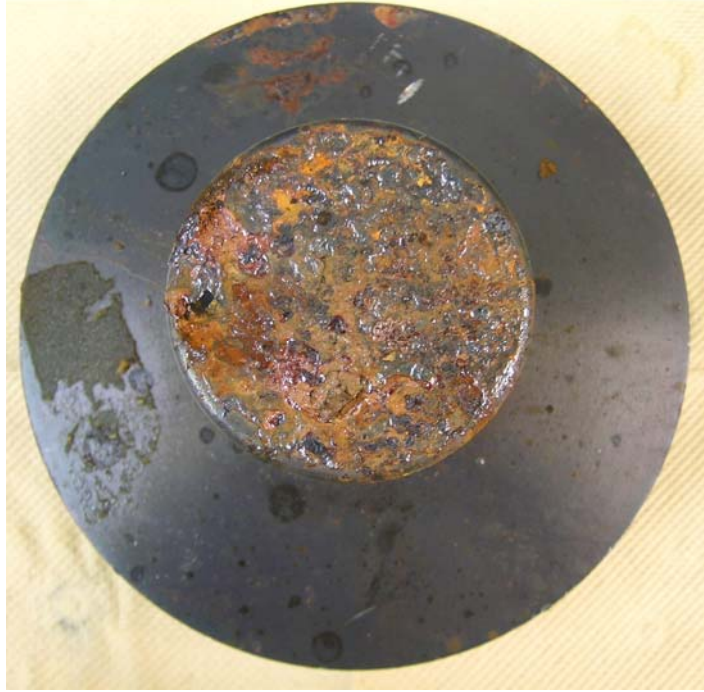
Figure 2: Part coated with Mobilarna, after 336 hours in humidity testing.

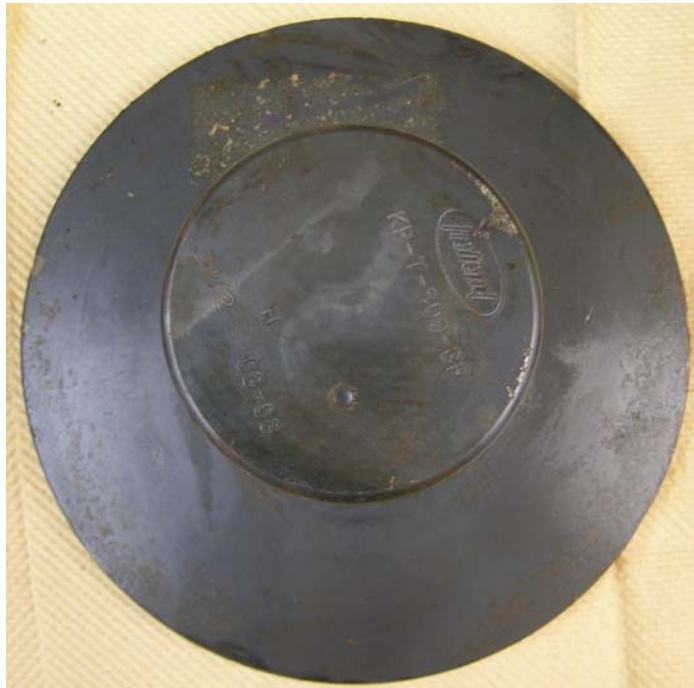
Figure 3: Part coated with VpCI-325, after 336 hours in humidity testing.

- 2) The second part, coated with VpCI-325, showed very little corrosion after 336 hours. Corrosion covered less than 1% of the surface area of the part.
