Evaluating Packaging Systems

Project #: 11-094-1125(bis)

Method: ASTM D-1735 Water Fog (100°F, >95% relative humidity)

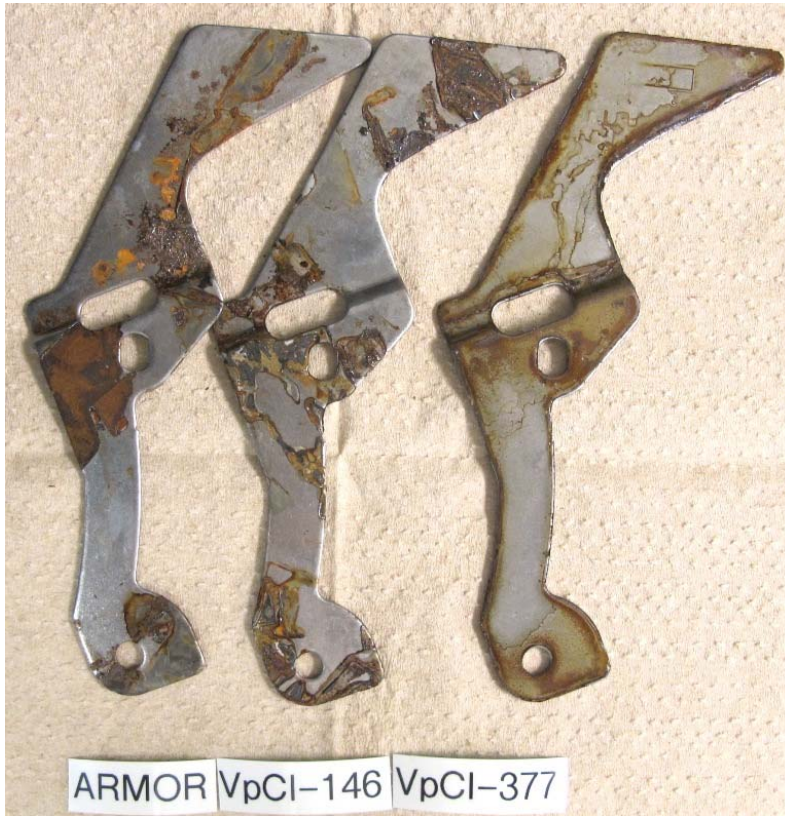
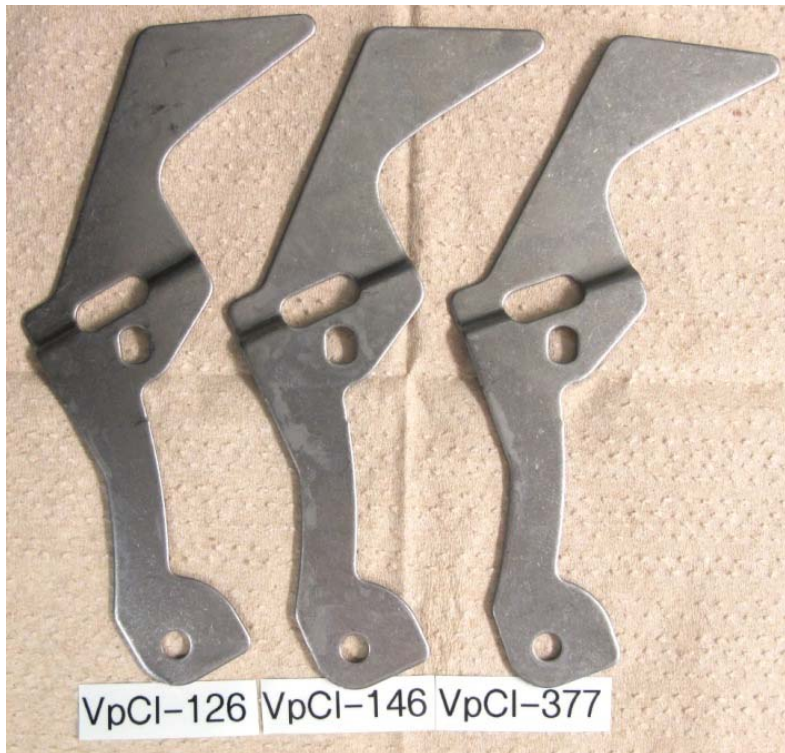
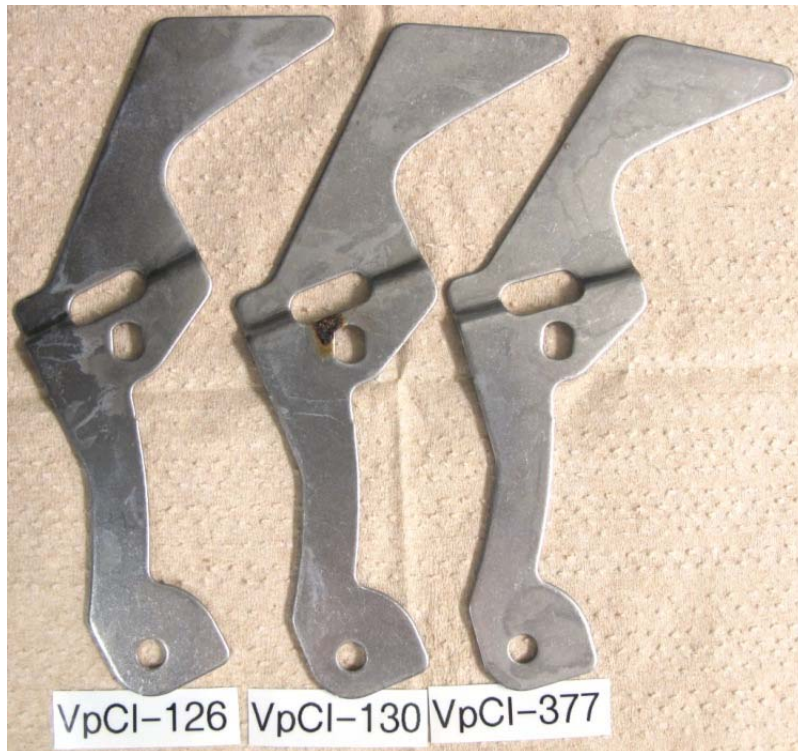
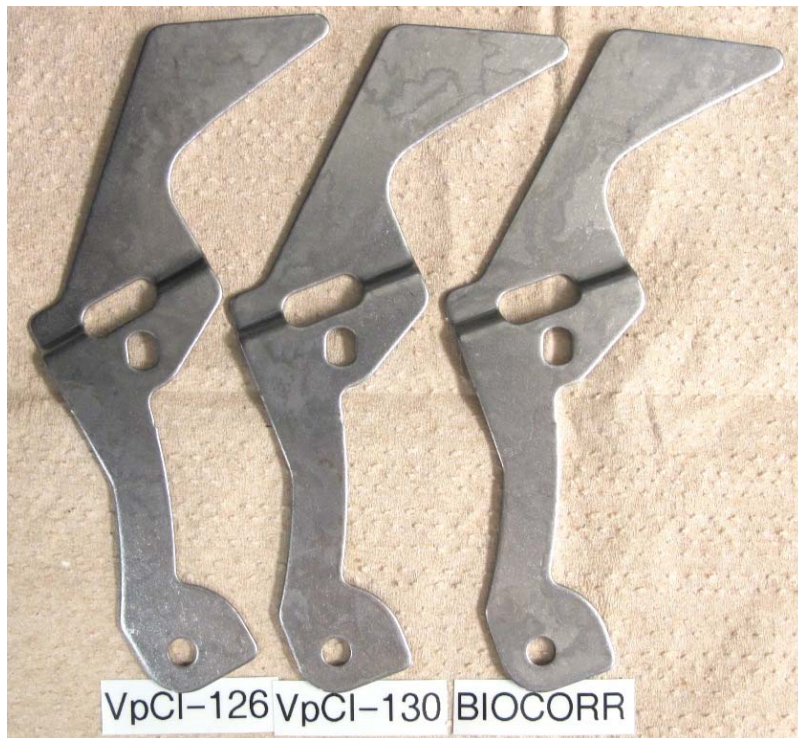
Photos:

Protection System	Time to Corrosion (Hours)
VpCI-377/Armor Film/146	336
VpCI-377/126/146	No corrosion
VpCI-377/126/133	932
BioCorr/126/133	No corrosion

Interpretations: Corrosion in this test was mainly seen in the package using Armor film. The pieces on the edge of the stack, in contact with the film, were the most severely corroded.

All Cortec packaging systems provided excellent protection, aside from a few lightly corroded parts in the VpCI-377/126/130 package.
