Comparing Rust Preventatives on Steel Panels

Project #: 12-253-1125.bis

Date: January 11, 2013

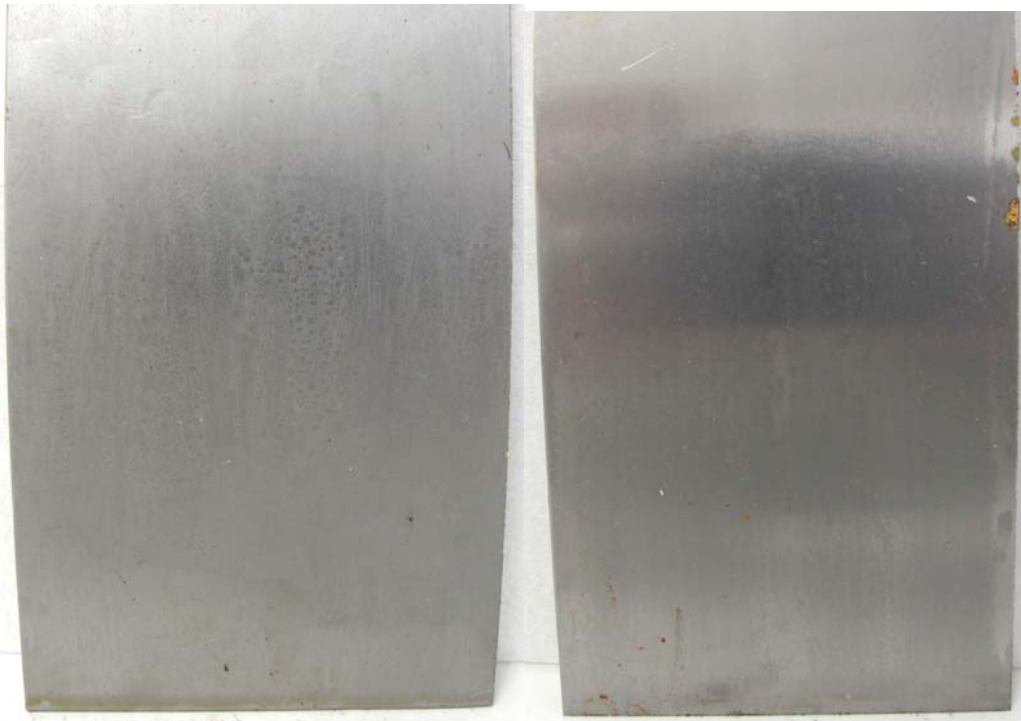
Photos of parts taken after 528 hours in humidity cabinet:

Ferrocote 673 BF

VpCI-325

The tests indicate that the best rust preventatives are VpCI-325 and Ferrocote 673 BF. The panel coated with VpCI-329 D also performed well, as it did not fail until 456 hours of testing. Pro-Cote 838C and Ferrocote EGL 1 did not provide good protection to the steel panels. The photos of the test panels after 528 hours in the humidity cabinet verify these results.

One significant factor should be considered when evaluating these test results. The panel treated with Ferrocote 673 BF left a thick oily residue behind after testing. This would require a thorough cleaning before the part could be used. The Cortec rust preventatives did not require significant cleaning after testing as it did not leave a thick film.
