Comparison of VpCI-325 and Fuchs RP on Camshaft Parts II

Project #: 13-140-1825.bis

Date: July 25, 2013

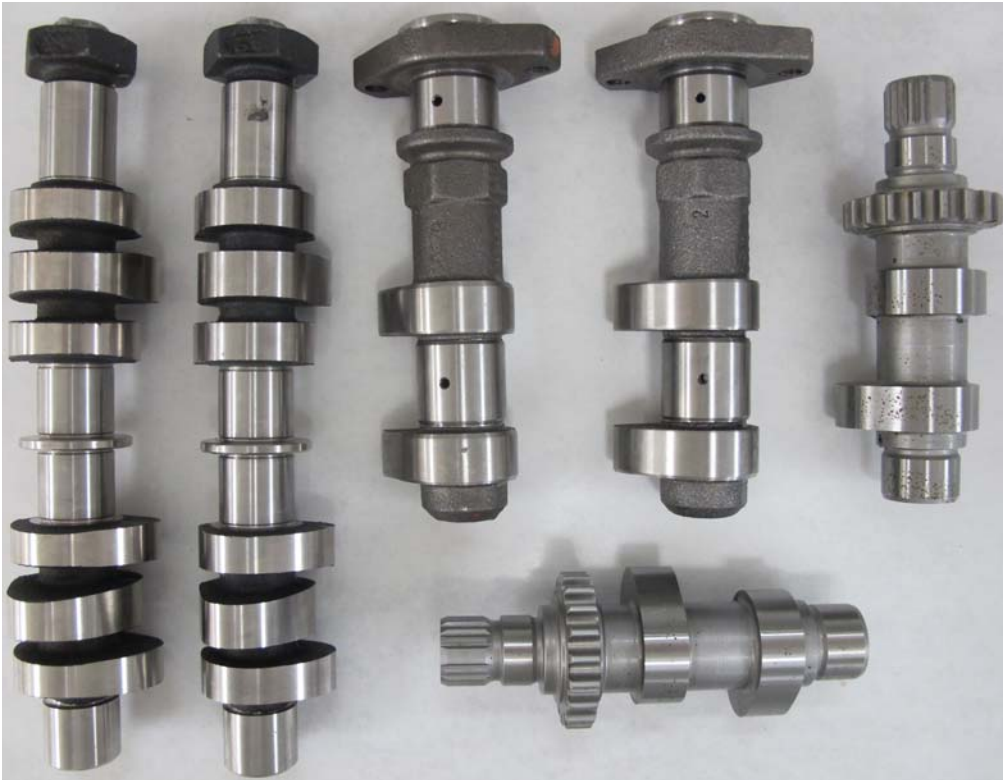
Before Rust Removal

Interpretations: The same results of corrosion failure were observed in this test as from the first report (13-018-1825). It has been confirmed that the rust removal process does cause some mild discoloration to the parts. This was especially apparent when the parts were left in the rust remover for prolonged periods of time. If parts are properly protected it should not be necessary to use rust removers and cause such discoloration.

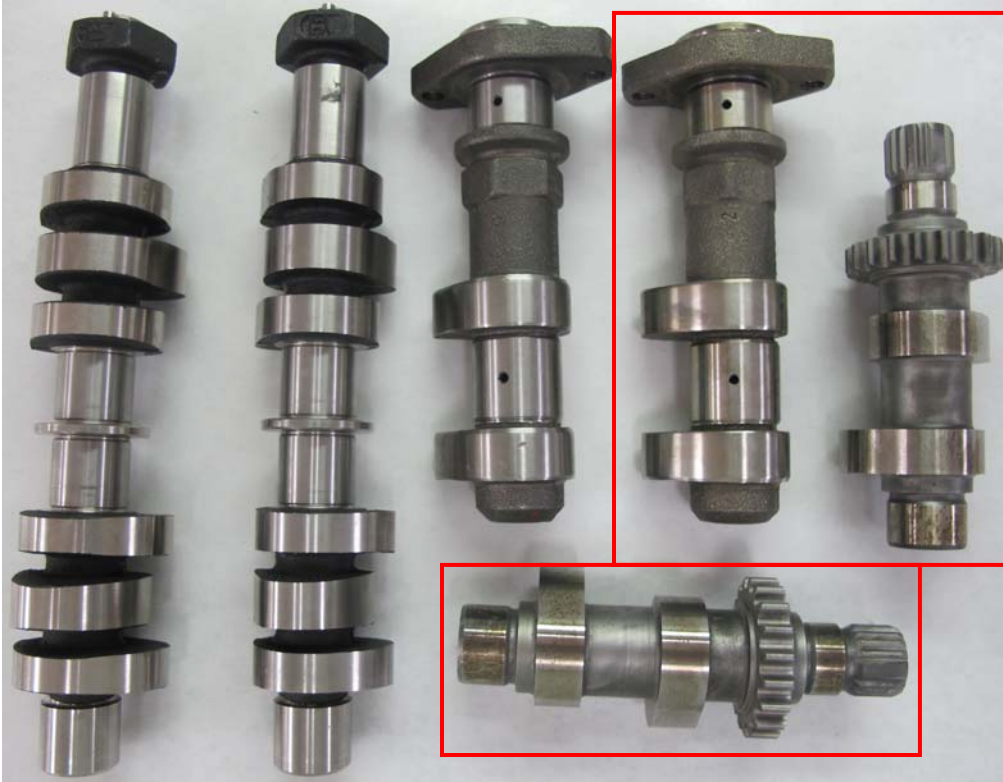
Three Parts after Rust Removal Highlighted in Red Boxes
