Evaluating Rust Preventive Options for Customer

Project #: 14-058-1825.bis

Date: April 2, 2014

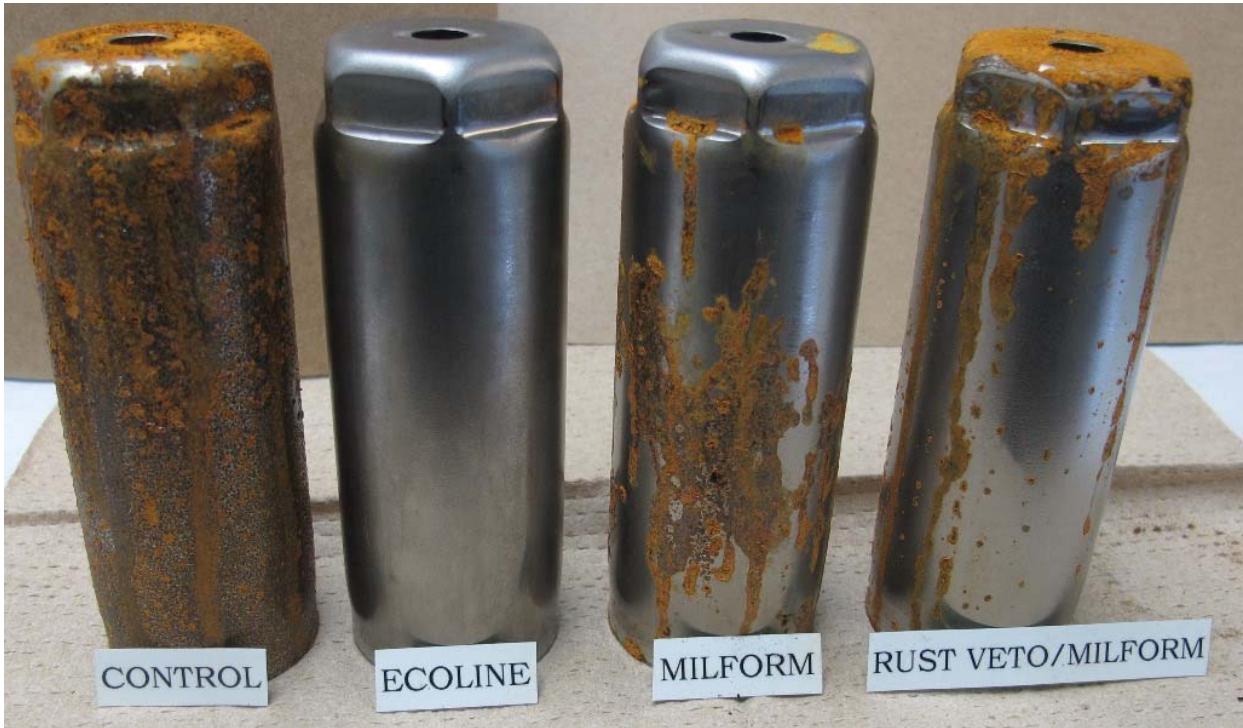
Figure 1: Customer's stampings after 144 hours in ASTM D-1735 testing.

Interpretations: After 144 hours in ASTM D-1735 water fog testing, the stamping treated with EcoLine Metalworking Fluid was corrosion free, while the other three stampings had moderate to severe corrosion.

Rust Preventive Used	Time to Corrosion (Hours)
None (control)	<8
Milform 8050	48
Milform 8050 + Rust Veto 4240	120*
EcoLine Metalworking Fluid	No corrosion

*The stamping treated with Milform and Rust Veto corroded between 54 and 120 hours; failure occurred during a weekend.
