Evaluating Corrosion Preventive Packaging Systems for GA Manufacturing

Project #: 14-225-1125.bis

Date: 12/4/2014

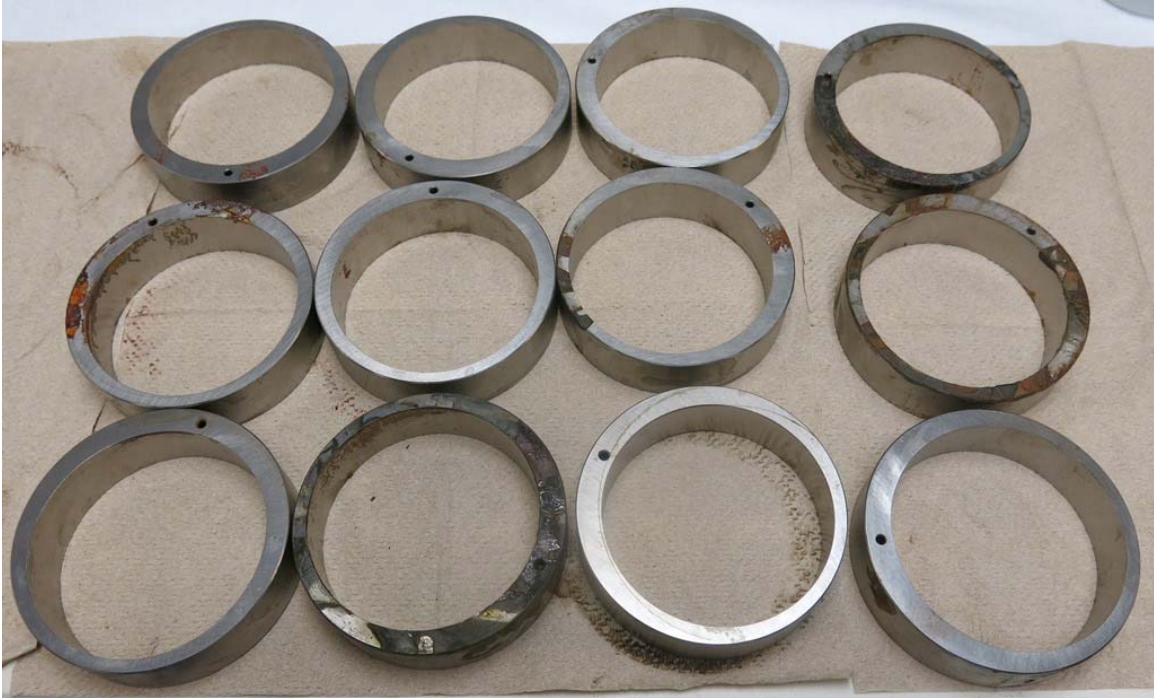
Figure 1: Zerust packaged parts, after 432 hours in ASTM D-1735 testing.

Customer has been using a packaging system with Zerust film and paper, wrapped around two rows of parts. This packaging system failed on all 12 parts in ASTM D-1735 testing. Parts corroded at different times and to differing amounts throughout the test; the first part showed corrosion after 96 hours.

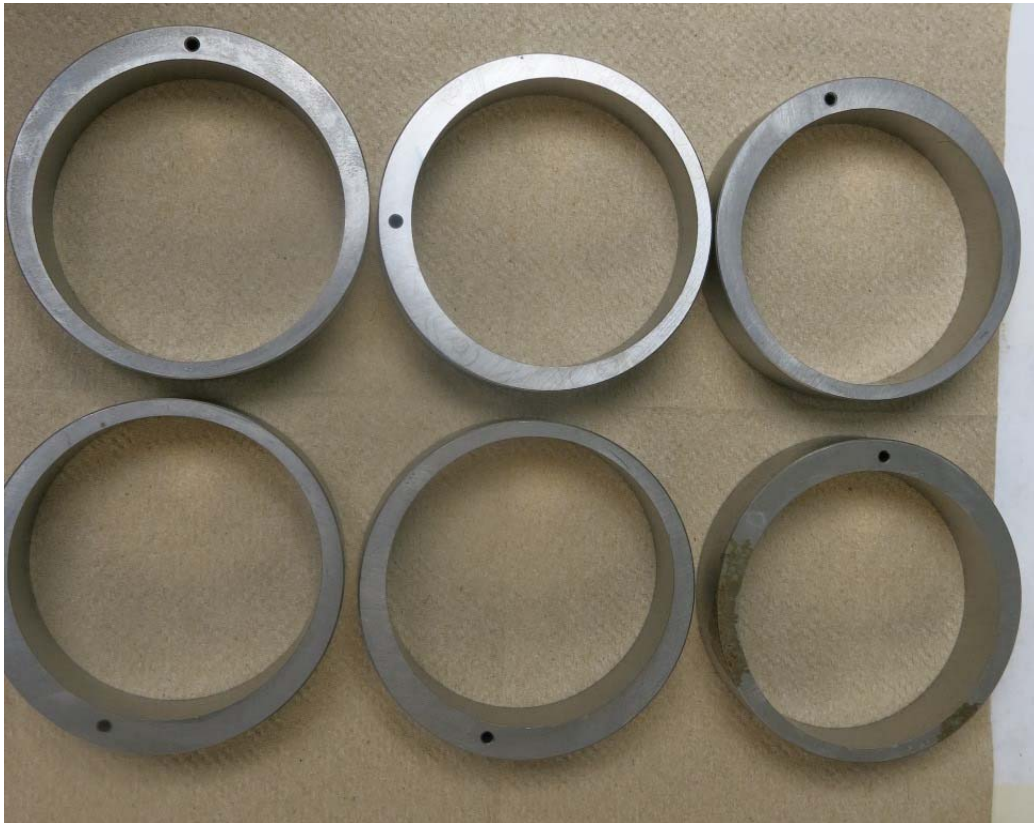
Figure 2: VpCI-126 packed parts, after 432 hours in ASTM D-1735 testing.

Conversely, VpCI-126 provided complete protection on 5 of 6 parts. The single part that corroded was in contact with the test chamber itself, and as such, was exposed to constant water contact.
