**ASTM 1748 Test of Metkool 10122, Nalco Protech 1300 RTU, and VpCI-377**

**Project #:** 15-019-1825

**Background:**

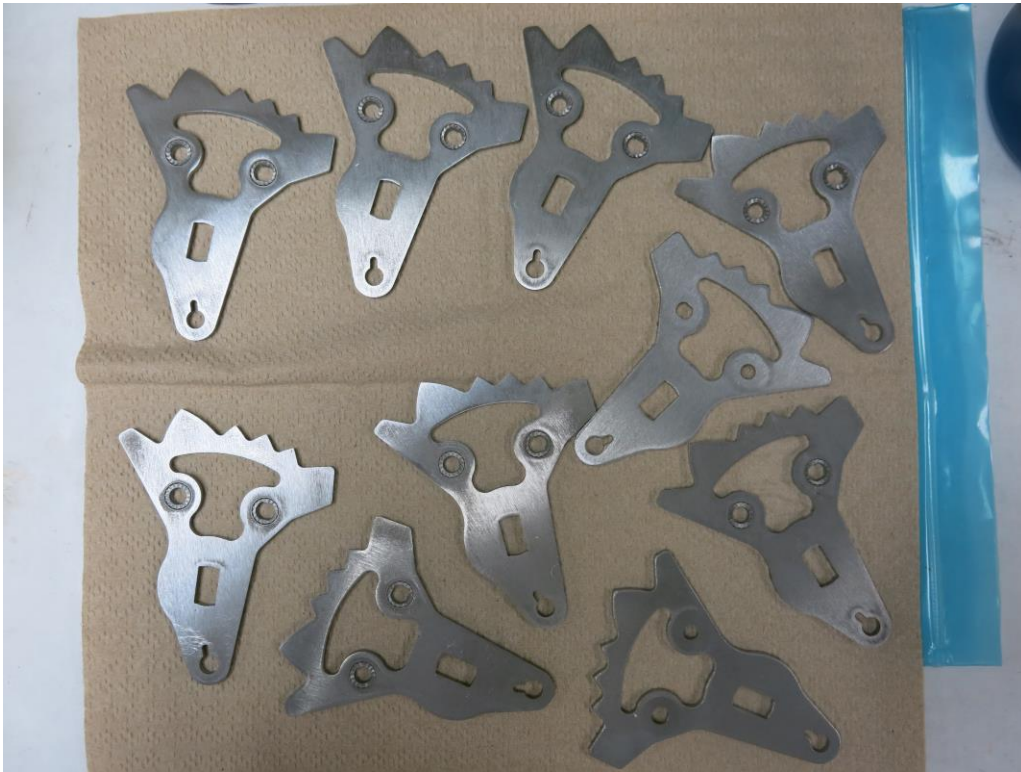
Picture 1: Initial Condition of the metal pieces

1. 10 metal samples were received in fair condition with one side noticeably duller in appearance than the other.
2. 12 small Metkool bottles
3. 12 small Protech 1300 bottles
4. Water sample marked "City Water"

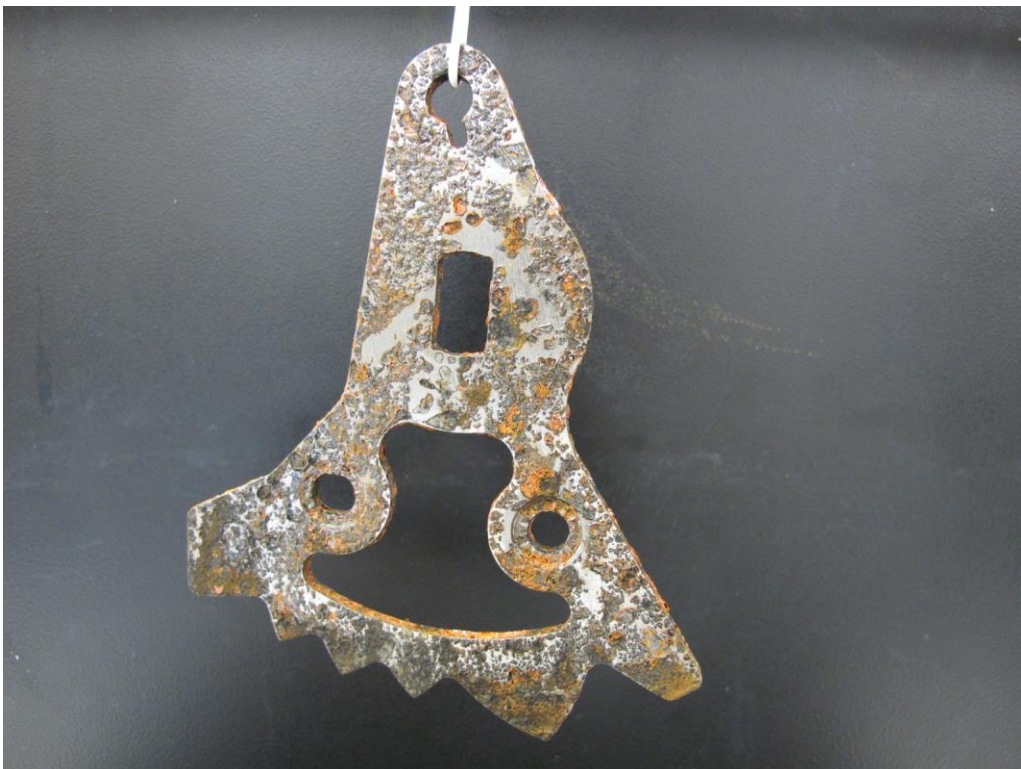
Picture 2: Condition of the control piece after less than 2 days in the chamber

Sample	Days before Corrosion Started	% Corrosion After Test
V-1	9	0.5
V-2	9	0.5
V-3	9	0.5
P-1	9	0.5
P-2	9	0.5
P-3	9	0.5
M-1	6	15
M-2	6	15
M-3	6	15
Control	< 2	90

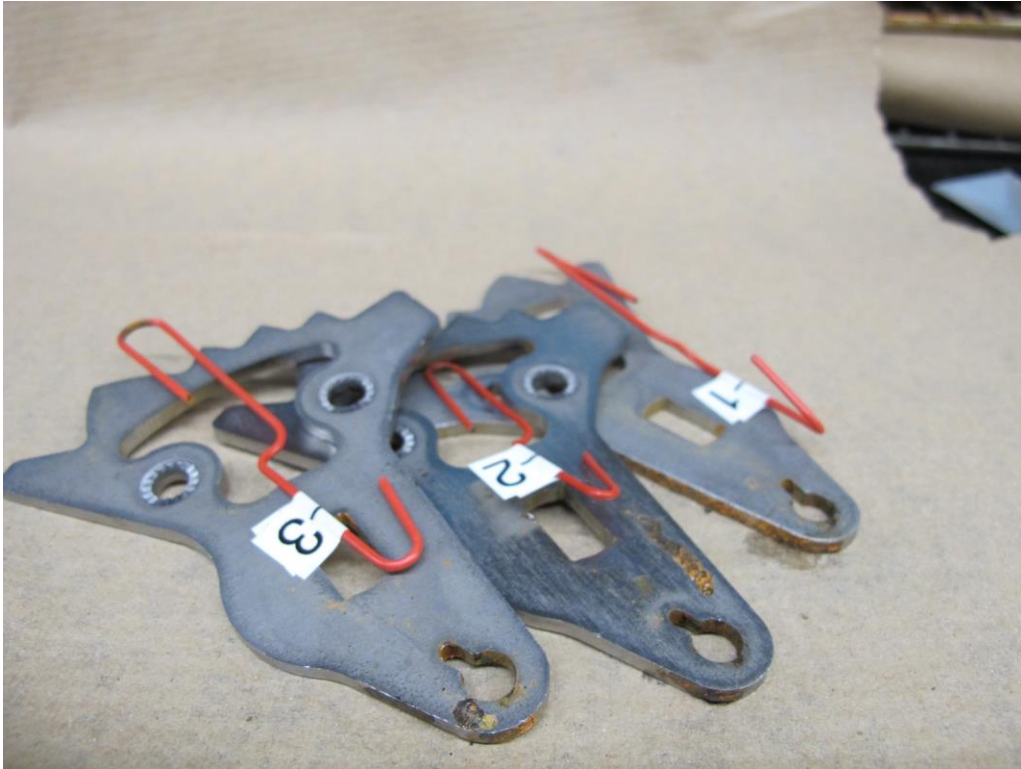
Picture 3: Condition of the VpCI-377 pieces after 9 days in the chamber

The results of the test indicate that even at only 4 wt% VpCI-377 provides significantly more corrosion protection than Metkool at 100 wt% and similar corrosion protection to Protech 1300 at 100 wt%. Additionally, Protech is a solvent based product with barium components which are not considered safe.

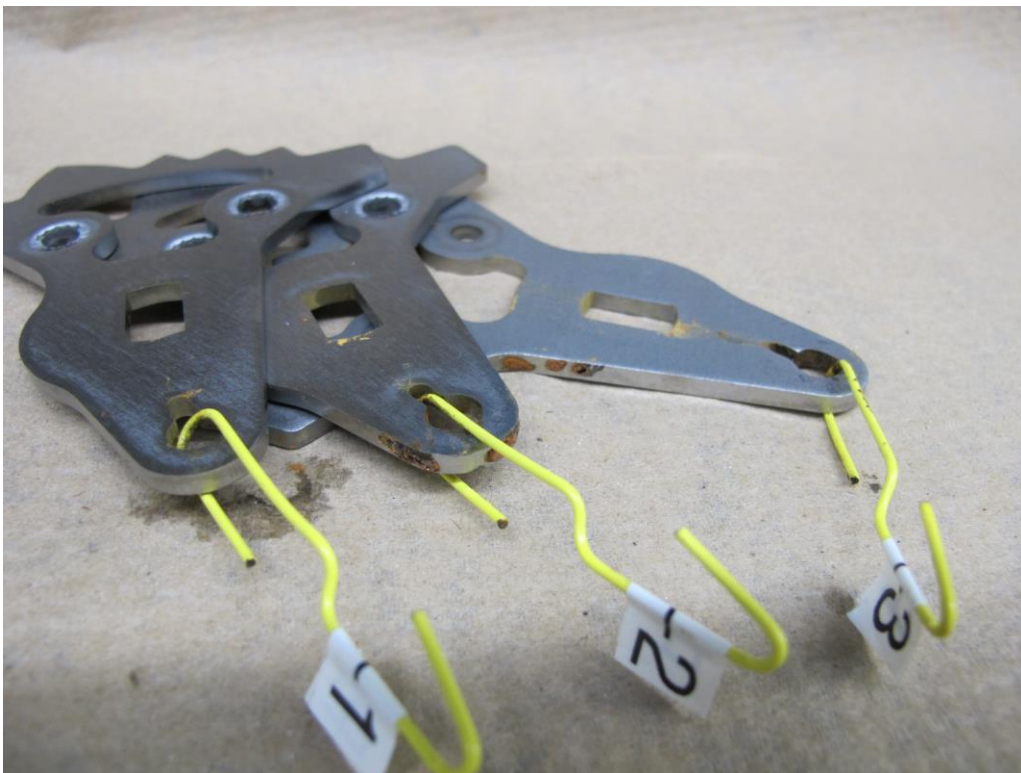
Picture 4: Condition of the Protech 1300 pieces after 9 days in the chamber

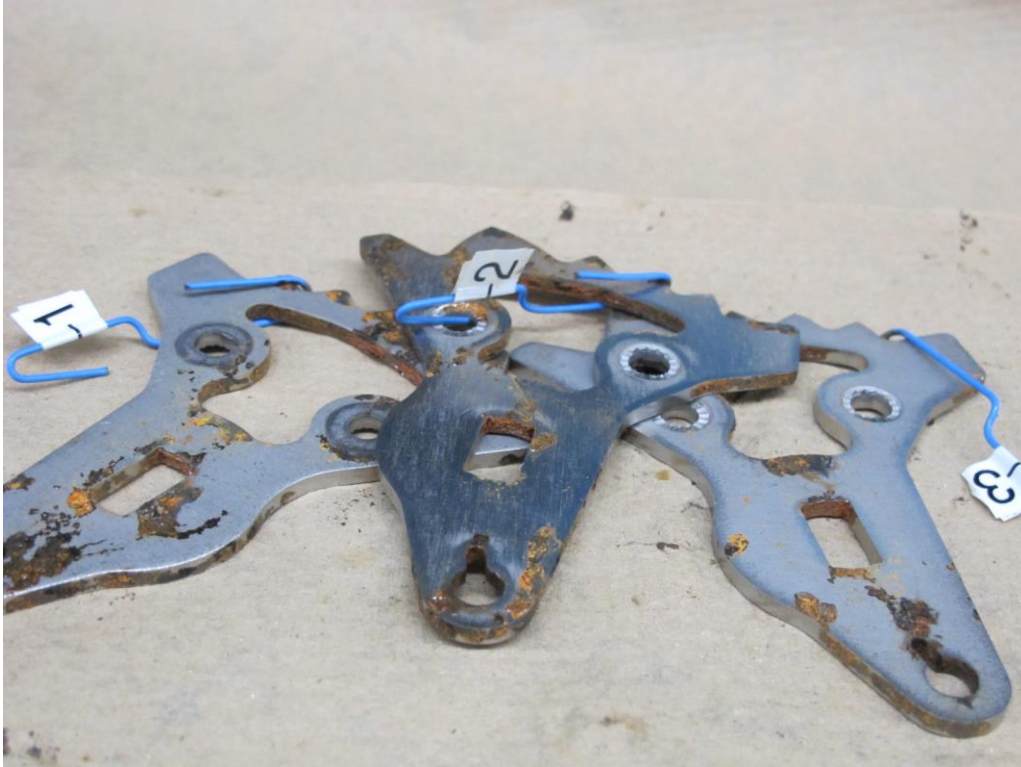
Picture 6: Condition of the Metkool pieces after 9 days in the chamber
