*Evaluating BioCorr and ALMCO 506R Rust
Preventive for Parts*

Project #: 15-253-1125.bis

Method: CC-018 (ASTM D-1748 Modified)

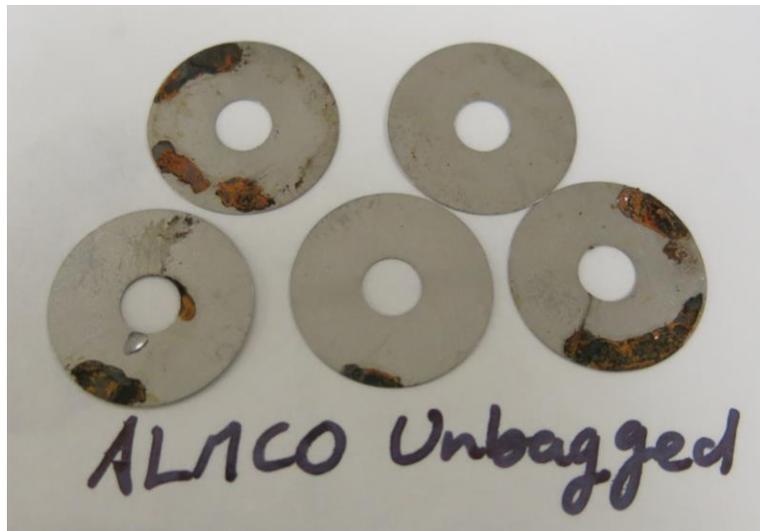
Picture 1: Washers protected with ALMCO 506R rust preventative, left un-bagged in ASTM D-1748 conditions for 139 hours. Severe rust can be seen on 4/5 washers.

Washers treated with BioCorr vastly outperformed the ALMCO 506R treatment on pieces left outside the VpCI-126 bags. The ALMCO 506R treatments allowed severe corrosion on the steel washers, whereas BioCorr only lent itself to minor discoloration, as shown above. In addition, all steel washers in VpCI-126 bags outperformed their un-bagged counterparts, showing the enhanced corrosion protection offered by Cortec's VpCI-126 film.

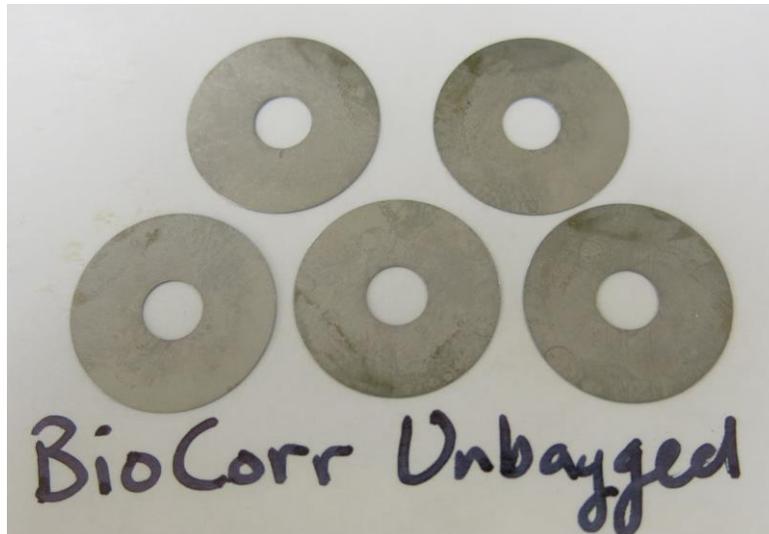
Picture 2: Washers protected with BioCorr Rust Preventative, left un-bagged in ASTM D-1748 conditions for 139 hour. Moderate discoloration can be seen on the washers.

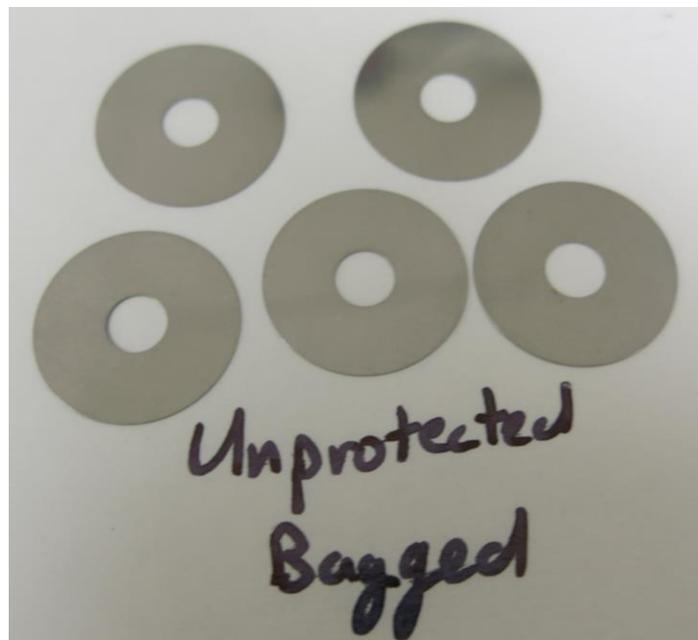
Picture 3: Washers, not coated with a rust preventative, bagged in VpCI-126 in ASTM D-1748 conditions for 139 hours. No discoloration can be seen on the washers.

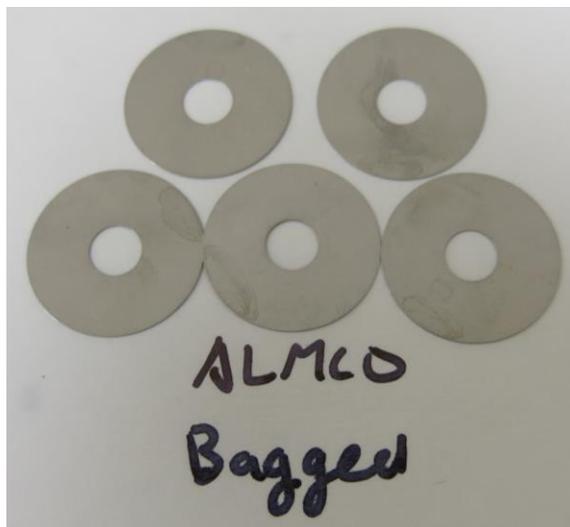
Picture 4: Washers coated in ALMCO 506R rust preventative and bagged in VpCI-126 in ASTM D-1748 conditions for 139 hours. No discoloration can be seen on the washers.

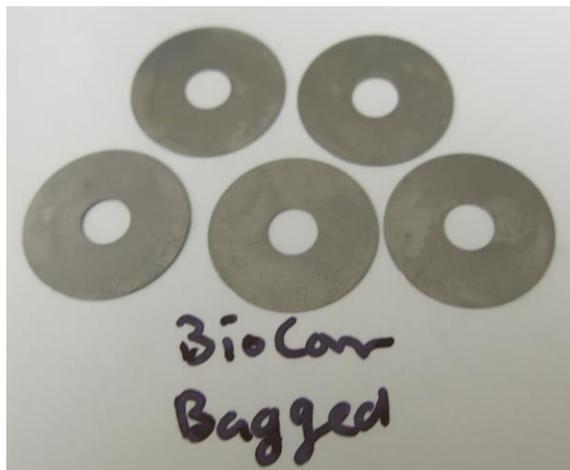
Picture 5: Washers coated in BioCorr Rust Preventative and bagged in VpCI-126 in ASTM D-1748 conditions for 139 hours. No discoloration can be seen on the washers.
