Evaluating Rust Preventive Liquids for Customer

Project #: 17-018-1825.bis

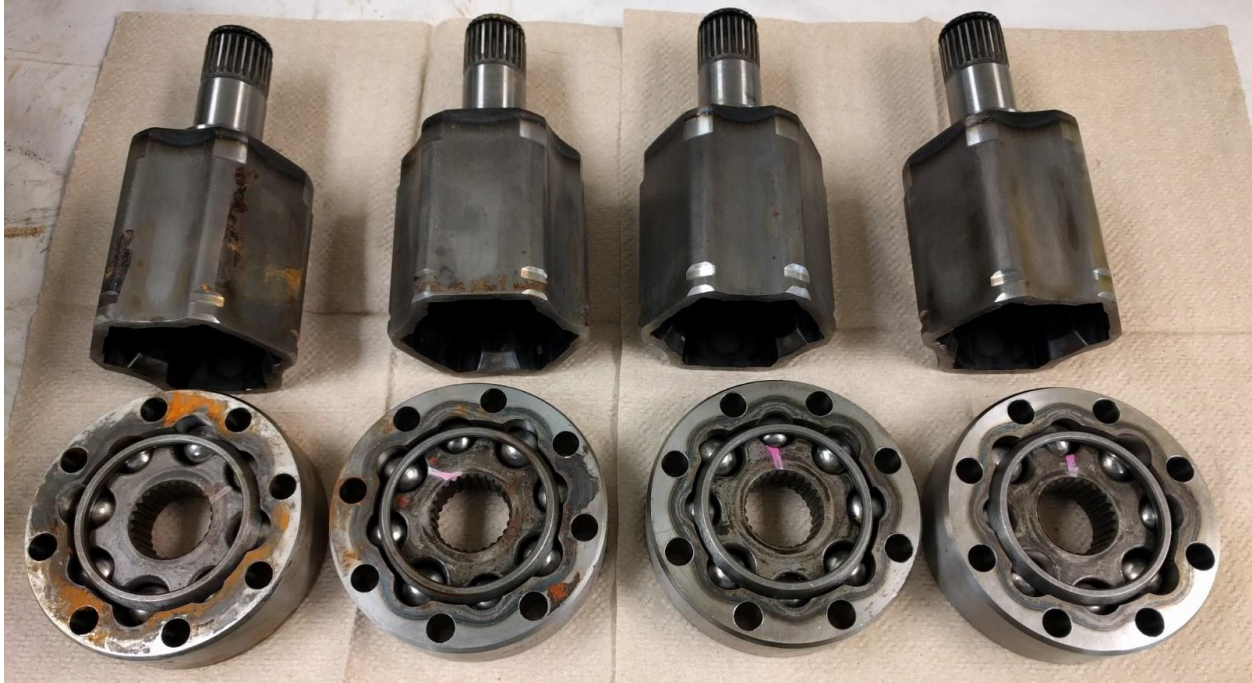
Figure 1: customer parts, after 600 hours in testing. From left to right: Control, Rustilo 4135HF, VpCI-325, EcoLine 3220.

Part Treatment	Time to Corrosion
None (Control)	312 hours
Rustilo 4135HF	600 hours
VpCI-325	No Corrosion
EcoLine 3220	No Corrosion

In an attempt to recreate the process used by the customer, parts were placed flat/face down on a plastic tray during testing. Although this tray was not thermoformed for the parts, application of the rust preventive was focused on the “top” of the part, and not sprayed on the entire part. After 600 hours of testing, both parts sprayed with Rustilo 4135HF showed signs of corrosion. Conversely, the parts sprayed with VpCI-325 were corrosion free, as were those coated with EcoLine 3220.
