# Addressing the challenges of Europe's ageing bridge infrastructure

Ana Juraga and Ivana Liposcak, Cortec, Zagreb, Croatia

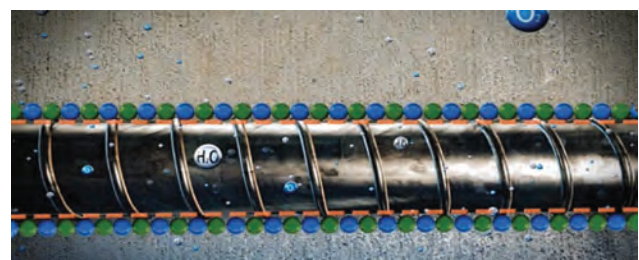
Below: MCI's form a protective layer on the surface of embedded steel reinforcement.

MCI's are based on amine technology. They are classified as mixed inhibitors, meaning they affect both anodic and cathodic portions of a corrosion cell. MCI is applied in many forms, including a concrete admixture or a topical treatment. It moves as a liquid through the concrete matrix via capillary action and migrates into a vapour phase throughout the concrete pore structure. When MCI encounters embedded metals, it has an ionic attraction to it and forms a protective molecular layer. This film prevents corrosive elements from further reacting with the reinforcement and reduces existing corrosion rates, greatly extending concrete's service life.

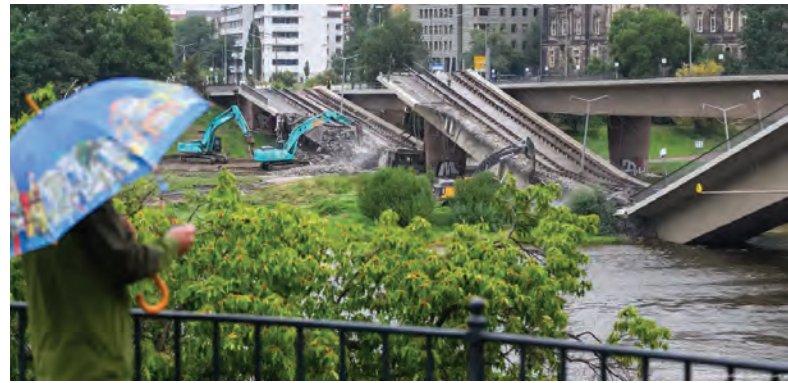
Above: Carola Bridge, Dresden.

The investigation has shown that the collapse was caused by corrosion of the concrete structure, which was built from 1967 to 1971. Renovation work has been ongoing on the same multi-lane bridge since 2019 and the collapsed section was supposed to be repaired the following year.

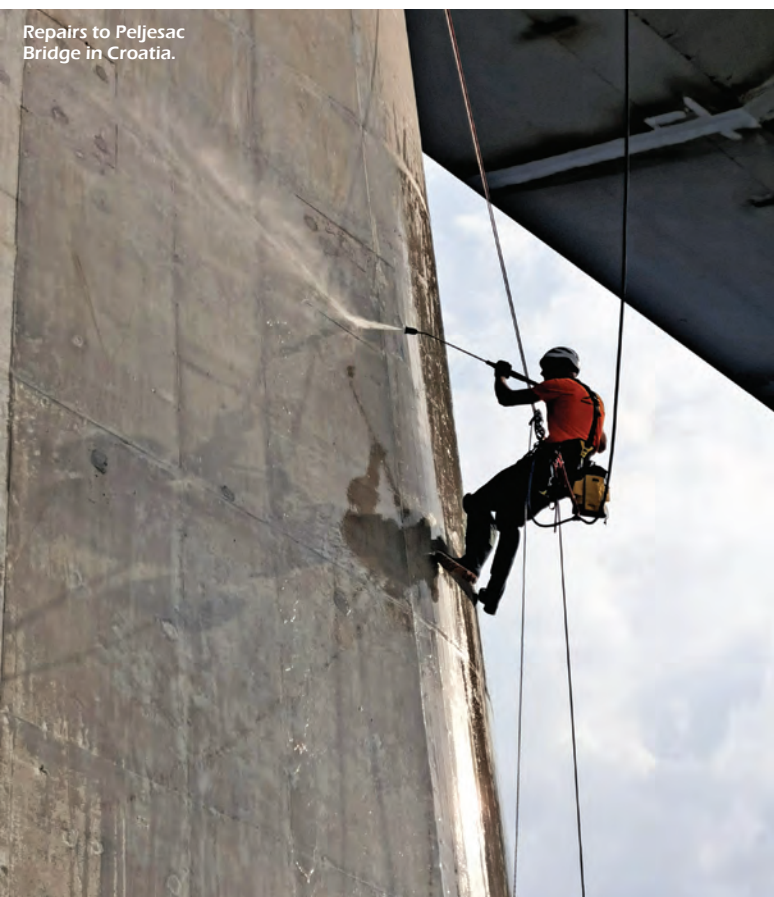
Repairs to Peljesac Bridge in Croatia.

A combination of coatings, cathodic protection of steel reinforcement in piles and pile heads, a concrete cover of 65–85mm, stainless steel reinforcement, and impregnation

of all concrete surfaces with Cortec MCI-2018 was chosen as the strategy to help the bridge achieve the designed service life. Cortec MCI-2018 was applied to the entire substructure of the bridge; all concrete parts were coated by a spraying technique. The work was performed in accordance with the project requirements and after surface preparation to ensure full functionality.

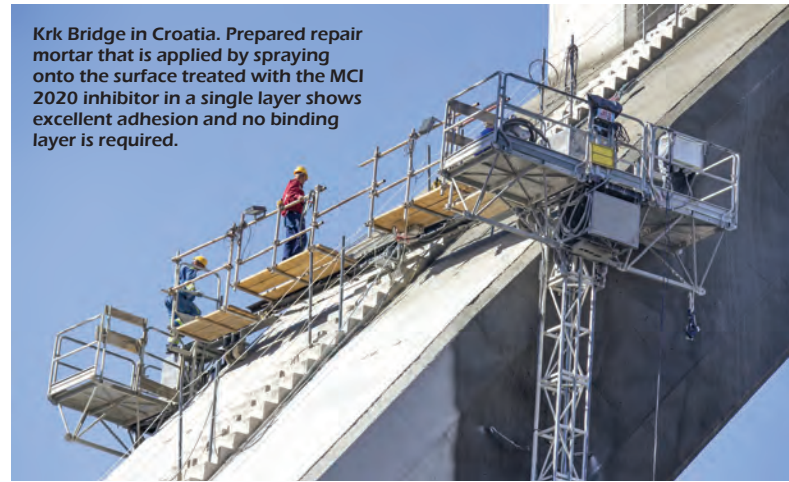
Krk Bridge in Croatia. Prepared repair mortar that is applied by spraying onto the surface treated with the MCI 2020 inhibitor in a single layer shows excellent adhesion and no binding layer is required.

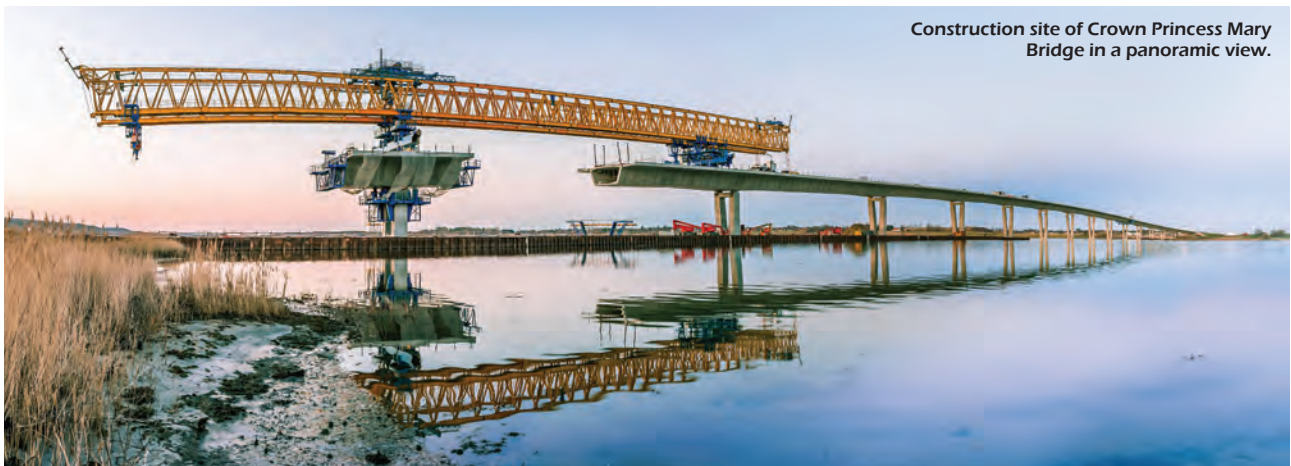
Construction site of Crown Princess Mary Bridge in a panoramic view.

as erecting the new Frederikssund Bridge in Denmark. The aim was to replace the old bridge built in 1935 by providing an alternative to the only currently active bridge over the fjord. The project included the design and construction of an 8km-long dual-carriageway highway, along with a bridge over the Roskilde Fjord. Cortec MCI 309 was used for corrosion protection of PT concrete segments.
