Testing Water Based Rust Preventatives on Machined Steel

Project #: 13-069-1825.bis

Background: The customer wants to compare VpCI-379 to a competitor water based rust preventative on highly polished, machined steel parts.

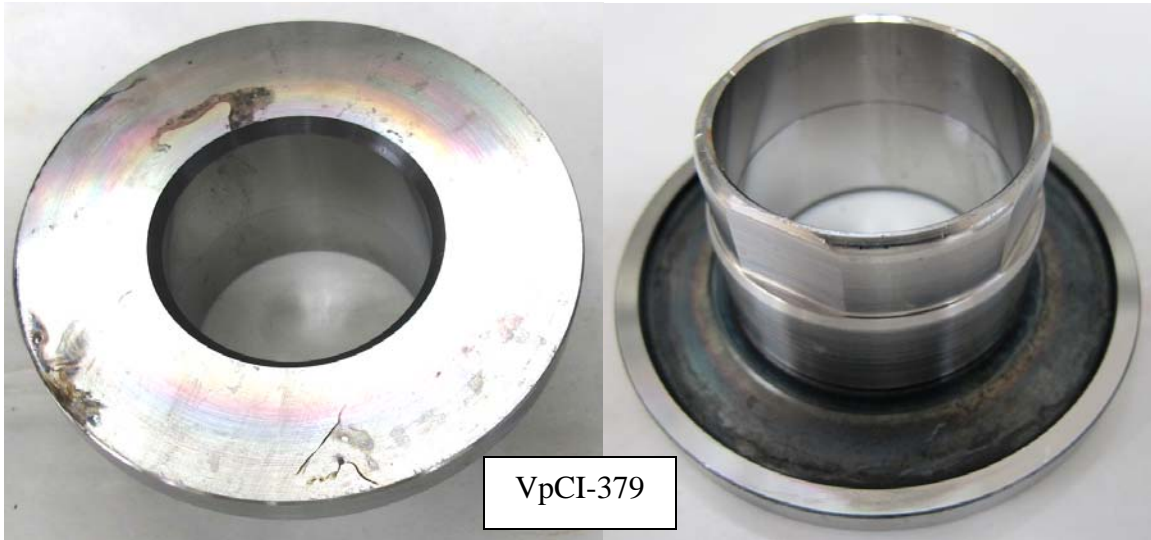
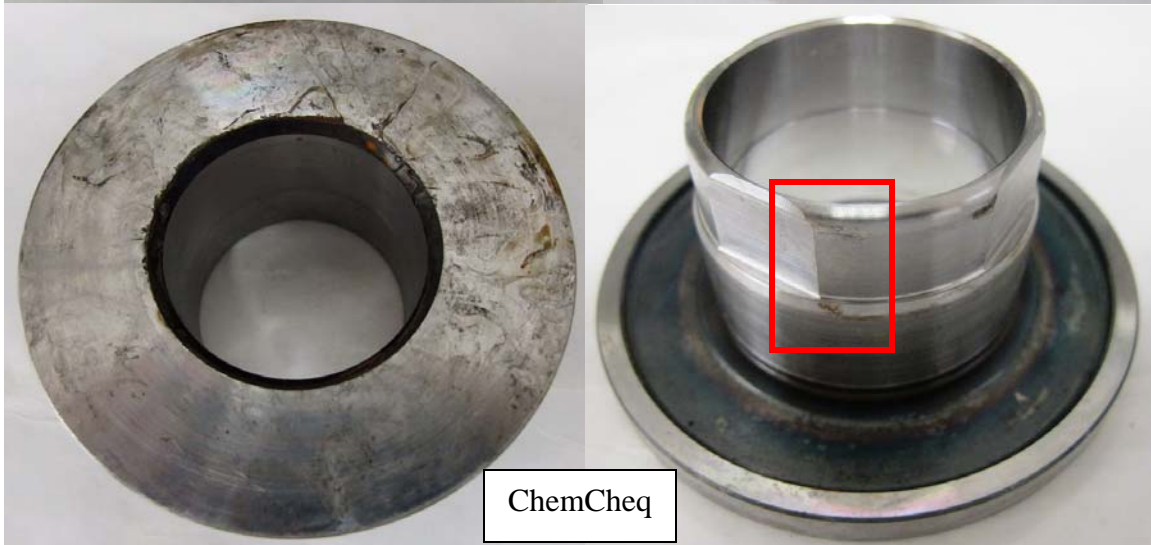
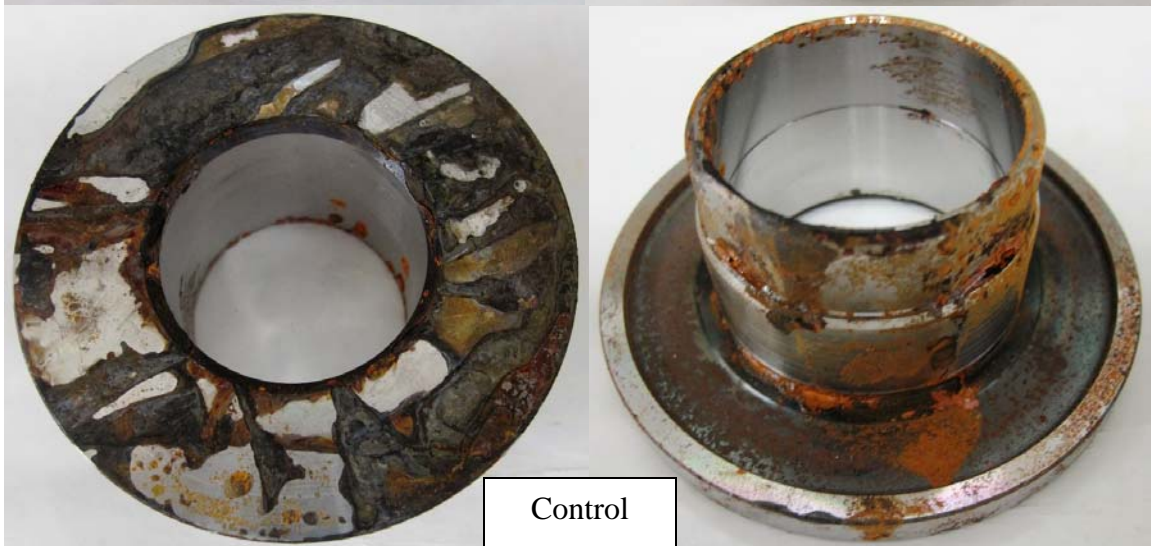
After 360 hours in ASTM D-1748 Modified

VpCI-379 provided much better corrosion protection than ChemCheq 6021C. After only 144 hours there were 3 spots of corrosion on the part treated with ChemCheq 6021C, while this did not occur until 336 hours with VpCI-379. Additionally, all of the rust spots on VpCI-379 were at the location the non-VCI bag was directly in contact with the metal. This may have pulled the coating off of the part and trapped water on the metal surface.
