FROM GREY TO GREEN NEWSLETTER

New Case Histories

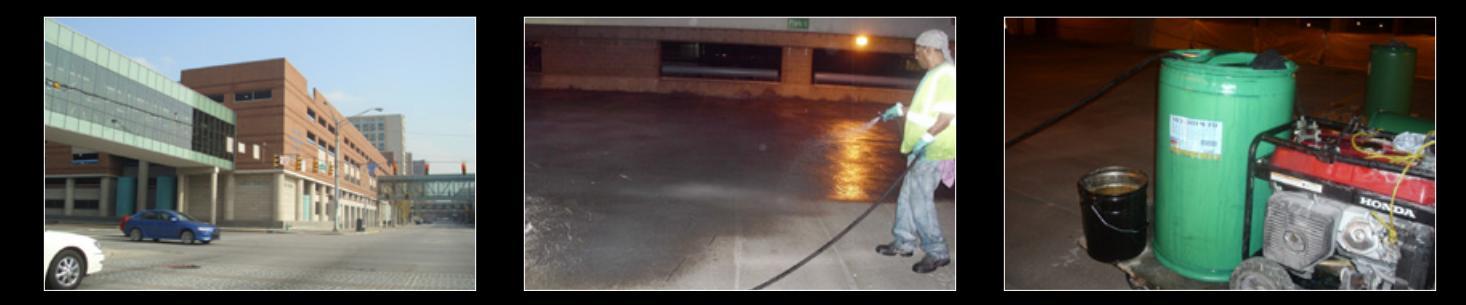
Washington St. & Senate Avenue Parking Facilities Preservation

The Washington Street and Senate Avenue parking garage in Indianapolis, Indiana was in need of repair consisting of miscellaneous crack injection, repair/replacement of expansion joints, pavers, concrete deck toppings, and sealing the concrete deck with a corrosion inhibitor water repellent with a fugitive dye. This repair was the second phase consisting of 380,500 square feet, (35,300 square meters). Following repairs, the concrete deck surfaces were blastracked and MCI[®]-2019 W FD was applied at 150 square feet per gallon (3.68 meter squared per liter) with a low pressure garden nozzle spray. MCI[®]-2019 W FD was applied on the weekends and the garage was opened for vehicular traffic on Monday morning.

The initial phase consisted of over 500,000 square feet (46, 465 square meters) and was completed in 2007. Due to the success of the first phase and durability thus far, MCI[®]-2019 W FD was chosen as the water repellent/corrosion inhibitor for the second phase of the project. The installation was successful and the garage was opened on schedule.

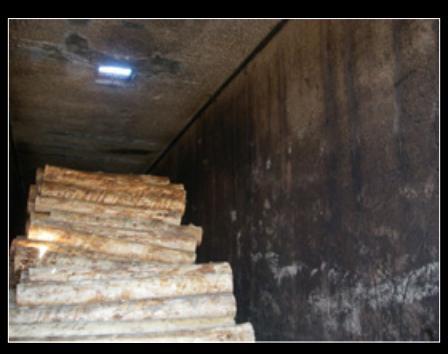
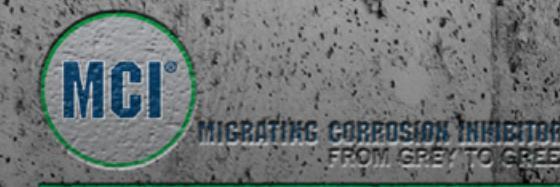
Restoration of Steam Vats, Seattle, WA

Steam vats used for processing logs into lumber had severely deteriorated to the point that the customer was considering demolition.

After removing the corroded concrete, the surfaces were treated with MCI[®]-2020 and the rebar was coated with MCI[®]-2023. Spalled areas were then patched with MCI[®]-2702. Lastly, the contractor epoxy injected structural cracks and coated the interior for chemical resistance and to brighten the spaces.

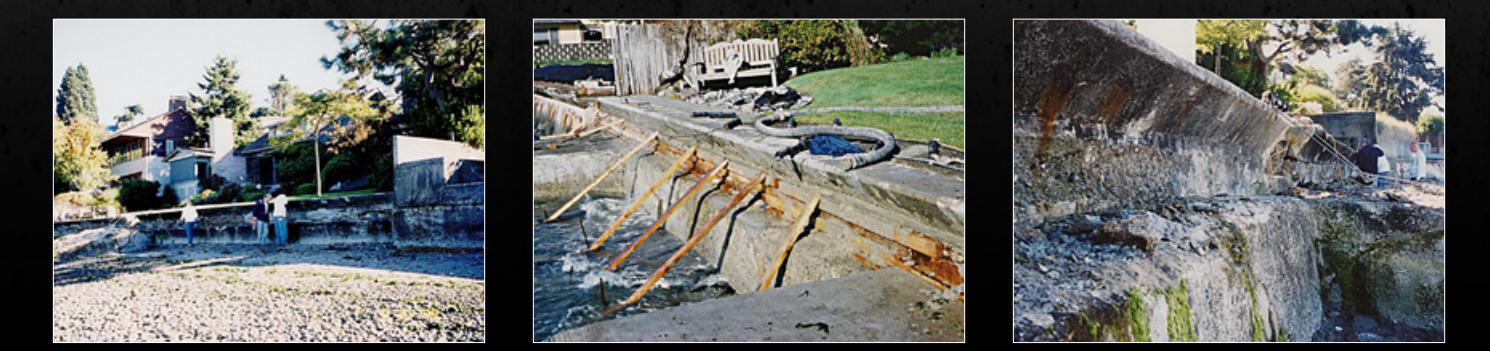
West Seattle Seawall Restoration, Seattle, WA

The concrete seawall was damaged by corrosion on the rebar. There was limited time to repair the damage between incoming tides.

After applying MCI[®]-2020 to the existing concrete, new concrete was poured to repair the area; then, when the concrete set, MCI[®]-2021 was applied to provide corrosion protection to the new concrete. Cortec[®] MCI[®] products effectively addressed the customers corrosion issues with minimal impact.

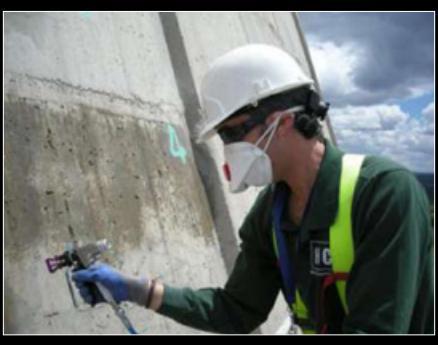
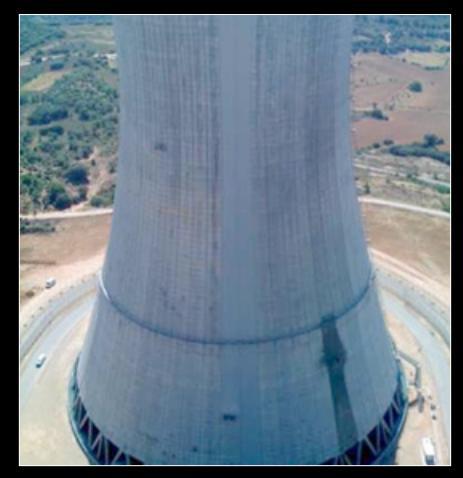
Trillo Nuclear Center Restoration, Spain

The Trillo Nuclear Power Plant in Spain was constructed in 1979 and put into service in 1988. By 2008, environmental impacts, such as low cover and high humidity and temperature, had caused extensive corrosion damage to the thin concrete walls and embedded reinforcing steel of the pressurized water reactor. The plant operators sought and environmentally friendly, economical solution to the problem.

Once the damaged areas were cleaned and prepared, rust was removed, reinforcing steel was passivated using repair grout containing MCI®-2006 NS, repair mortar with MCI®-2006NS was applied to patched areas, and MCI®-2020 and an anti-carbonation coating were applied to all surfaces. MCI®-2020 migrated a considerable distance through the concrete and provided protection to embedded reinforcing metals reducing the corrosion rate and extending the useful service life of the structure. MCI®-2006NS in the grout and repair mortars migrated to adjacent areas to protect embedded metal. All applications were easy to apply, highly effective, safe to handle, non-toxic, and provided an economical restoration to Trillo Nuclear Central.

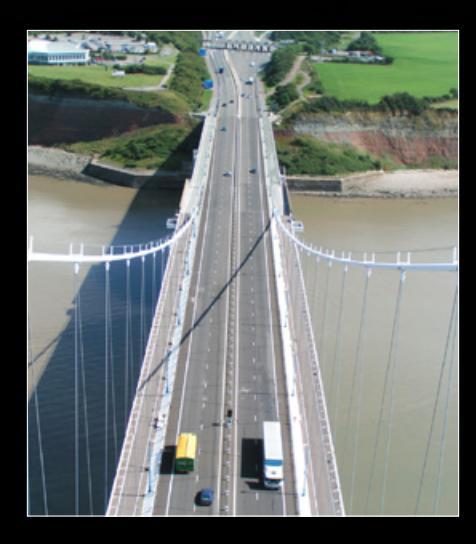
Severn Bridge Suspension Cable Protection, Wales

The suspension cables on this type of bridge are known to corrode over a long period of time. The 20 inch (508 mm) diameter main cable is constructed from 8322 high tensile galvanized wires of 0.196 inches (4.98 mm) in diameter, with a total area of 314 square inches (202,580 square millimeters) of which approximately 20% is comprised of voids. The cable is wrapped in 0.144 inch (3.66mm) mild steel galvanized wire. Dehumidification is used to reduce the moisture level around the cables but does not provide perfect protection. Cortec[®] inhibitors were chosen by the engineers to augment the dehumidification during the drying phase and act as a back-up during shut down periods or maintenance when the dry air supply is not available.

Original thoughts were to fog a VpCI[®] powder or water-based inhibitor into the system but neither option was acceptable to the owner. A test rig was built using VpCI[®]-105 Emitters as the corrosion inhibitor source to ensure no detrimental effect on the materials/components of the cable system. The testing proved positive but the larger challenge was to ensure that enough of the emitters entered the airflow wand would be distributed as needed. Cortec's PTC Emitters were developed as a result.

A simple hatch and crate system that is part of the main dehumidification pipework was developed. This system allowed the inhibitor to be placed in the airflow without disrupting the system when the product needed to be changed out. The dosage rate of 5 PTC Emitters per 10 injection sleeve inputs per month was initially determined to be the effective quantity and frequency of change.

The system has been running since 2007 and provided the PTC Emitters are changed every 3 months the corrosion rate measured by probes has remained constant. Testing is now being carried out with a newly developed VpCI[®] sensor solution to confirm the presence of VpCI[®] inhibitor in and around the cables. By using the PTC Emitters with the dehumidification system, the number of strand breakages per year is now down to zero.

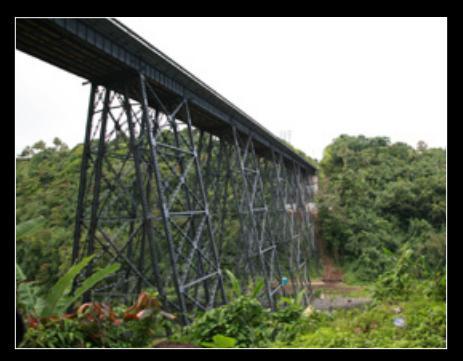
Hakalau Seismic Retrofit, Big Island Hawaii

Corrosion on the steel girders resulted from volcanic sulfur dioxide and chloride enriched moisture due to close proximity to the Pacific Ocean and Kilauea Volcano.

Cortec[®] VpCl[®] CorrVerter[®] provided an excellent solution for priming the rusty steel surface where further corrosion protection was required and proper surface preparation was difficult to achieve. MCl[®]-2005 NS and MCl[®] Mini Grenades were an excellent solution. Due to their ease of use and ability to adhere and protect embedded steel surfaces, greatly increasing expected service life.

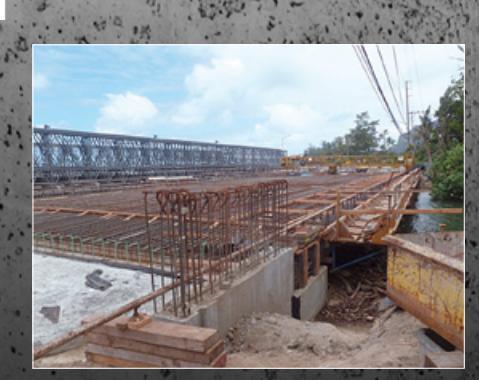
Punalu'u Stream Bridge, Oahu, Hawai

Punalu'u Stream Bridge is located steps away from the Pacific Ocean, enduring constant trade winds as high as 40 mph in the winter coming off of the ocean. The atmosphere is highly contaminated with chlorides and sulfur dioxide from the nearby Kilauea Volcano located on Hawaii's big island and inland water reports show rainfall is at pH 4.5. The acid rain combines with chlorides to create a very corrosive environment.

MCI®-309 was injected along with air just after the post-tensioned cables were placed and MCI®-2005NS admixture was added into the new concrete placed on the bridge. MCI®-309 is readily absorbed by the grout and does not need to be removed when the post-tensioned chambers are injected with grout. Cortec's MCI®-309 and MCI®-2005 NS provide excellent protection in an aggressive environment. MCI® was used because it provides protection to the steel surface, greatly extending the service life of the structure.

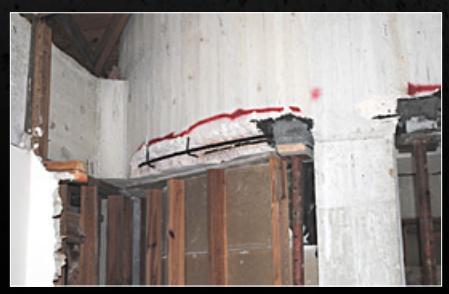
Las Olas Isles Residential Restoration, Ft Lauderdale, FL

A multi-million dollar waterfront residence circa 1940 was experiencing severe concrete deterioration from: high chlorides (sea salt) and excessive humidity which makes the chlorides "sticky" – holding them on the surface of the concrete and provides electrolytes to keep the corrosion cell working with little surface rain.

Because of the extent of the spalling, some columns and beams were deemed too deteriorated and were replaced. Crews then followed the ICRI Guidelines for making structural repairs using VpCI®-422 to clean the rebar, VpCI®-415 to neutralize, MCI®-2246 bonding agent and a modified repair mortar. MCI®-2020 V/O was then applied to all concrete grade beams, tie beams and columns. The owner anticipates prolonged service life and reduced maintenance costs which will help if they ever decide to sell the property.
