CASE HISTORY

Refurbishing Tennis Club's Infrastructure

CUSTOMER
Longboat Key Tennis Center

LOCATION
Longboat Key, Florida

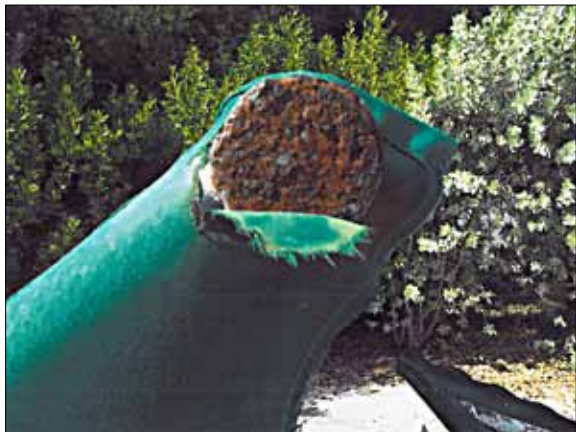
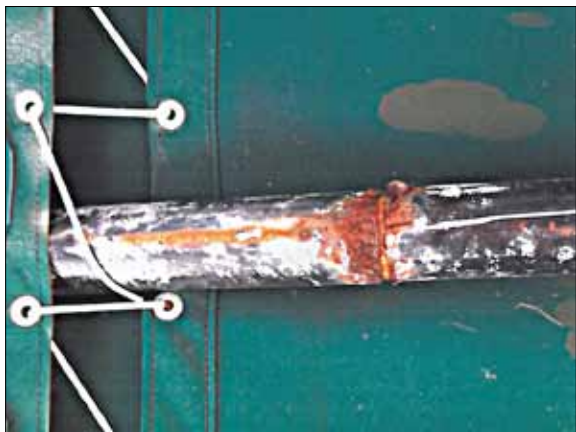
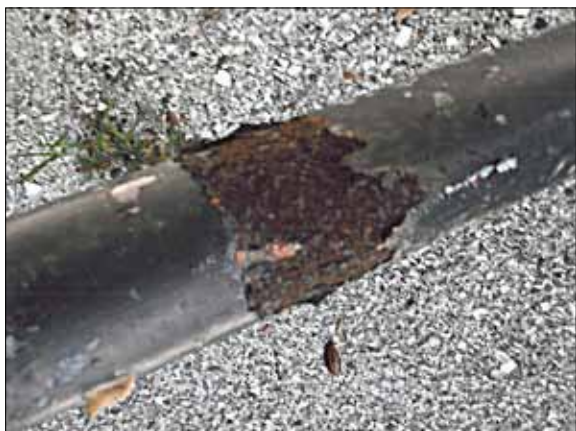
PROBLEM
The steel structures of the Longboat Key Tennis Center showed excessive pitting caused by constant exposure to the tropical Florida climate in proximity to the Gulf of Mexico; and regular watering using recycled water with a high sulfur content.

APPLICATION
The structures were wire brushed to remove loose rust and dirt particles. Cortec's CorrVerter® was then applied, followed by a top coat of VpCI®-386 Black at a DFT of 4 mils (100 microns).
