Evaluating Current Fluid Used by Falk Paper

Project #: 07-275-1125

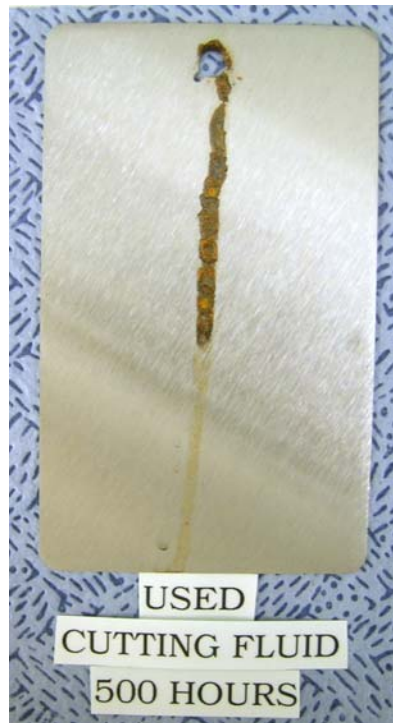
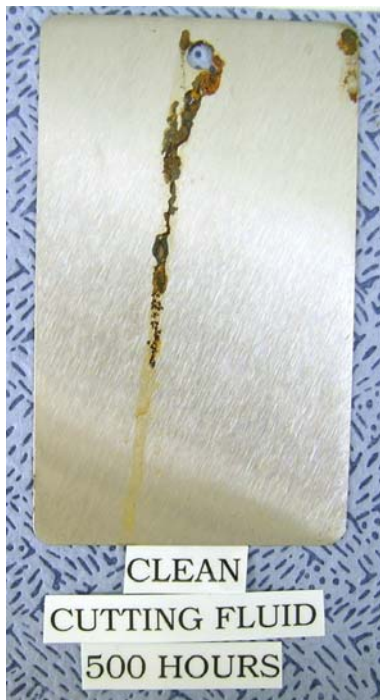
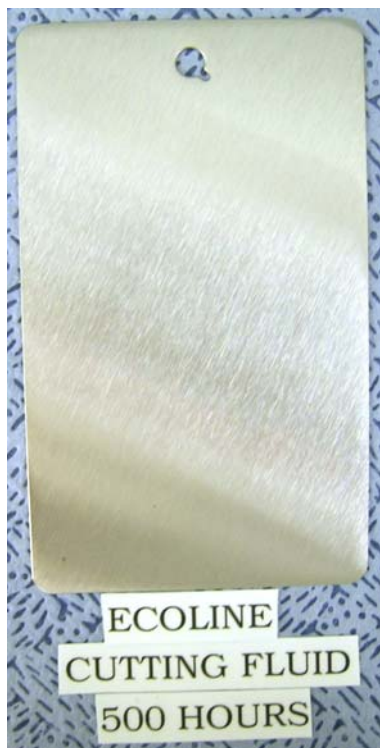
- 1) Two samples of the Falk cutting fluid were used in testing.
 - a. One sample was marked 'Used' and the other was marked 'Clean'.
 - b. Both samples had two distinct layers in them; a blue green liquid with a brown layer on top.
 - c. Both samples were mixed prior to testing.
- 2) Three carbon steel panels were coated.
 - a. A1: Coated with the 'Used' Falk cutting fluid.
 - b. B1: Coated with the 'Clean' Falk cutting fluid.
 - c. C1: Coated with a 5% solution of EcoLine Cutting fluid.
 - d. D1: Control
- 3) The three panels were then hung to dry overnight.
- 4) All panels were then placed in ASTM D-1748 humidity cabinet.
- 5) Panels were visually inspected periodically.
- 6) After 500 hours, all panels were removed from ASTM D-1748 humidity cabinet.
- 7) Panels were visually inspected and photographed.

| Panel | Time to Failure (Hours) |
| A1 | 120 |
| B1 | 216 |
| C1 | DNF* |
| D1 | <24 |

DNF – Did not fail during 500 hours of testing.

Conclusion: The two submitted cutting fluid samples provided little corrosion protection. Neither product lasted half of the 500 hour testing time, while EcoLine Cutting Fluid showed no corrosion after this amount of testing.
