Comparing VpCI-126 to NTI Film for Metal Stampings

Purpose: To compare the corrosion protection of VpCI-126 blue film to a similar gauge NTI film on parts from customer.

Project #: 09-213-1125(bis)

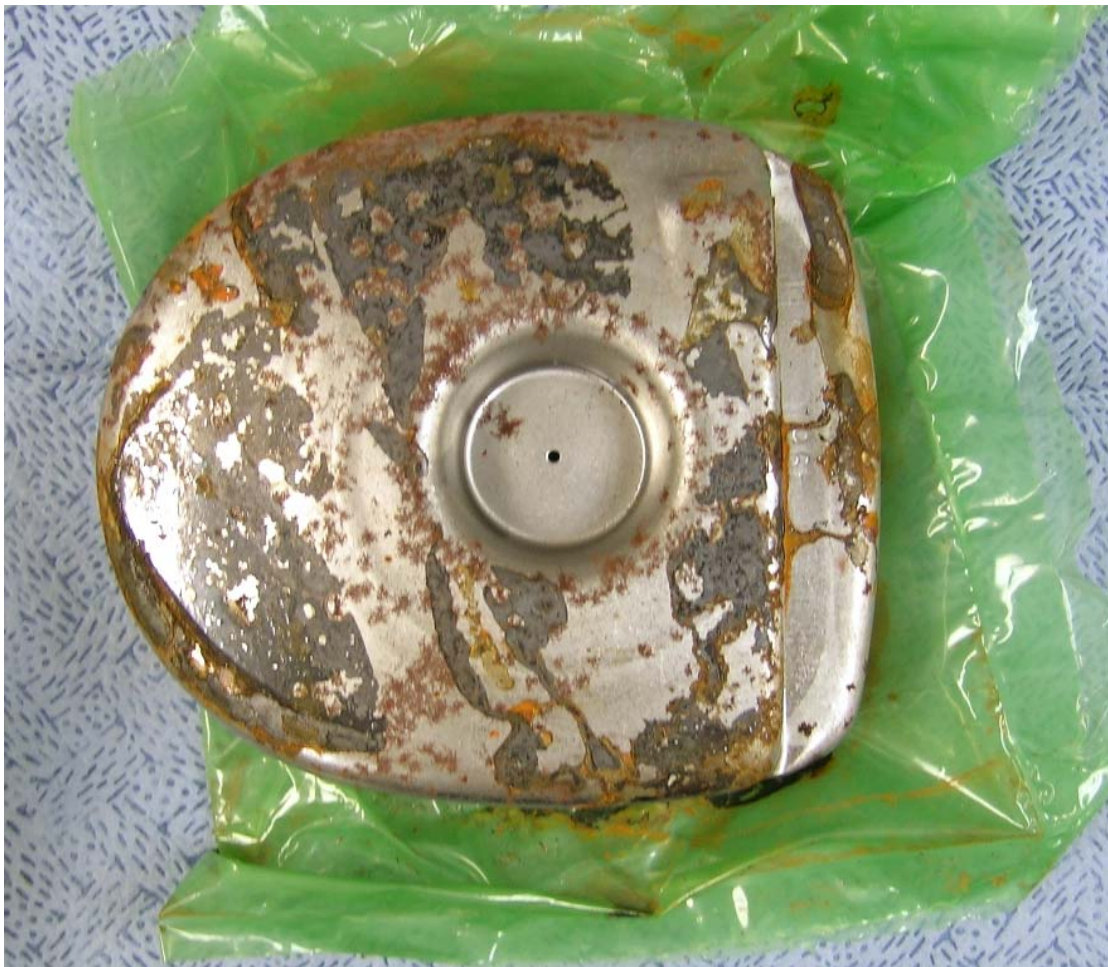
Figure 1: Metal stamping, wrapped in NTI film, after 840 hours of humidity testing.

Film Used	Time to Failure (Hours)
NTI green film	<72
VpCI-126 Blue Film	840

Conclusion: VpCI-126 Blue Film provided significantly better corrosion protection than the NTI film. In total, the Cortec film lasted nearly 12 times longer than the NTI film. This result suggests that no additional rust preventive is necessary during the pre-packaging steps. Results of FT-IR test don't show any corrosion inhibitors in NTI film.

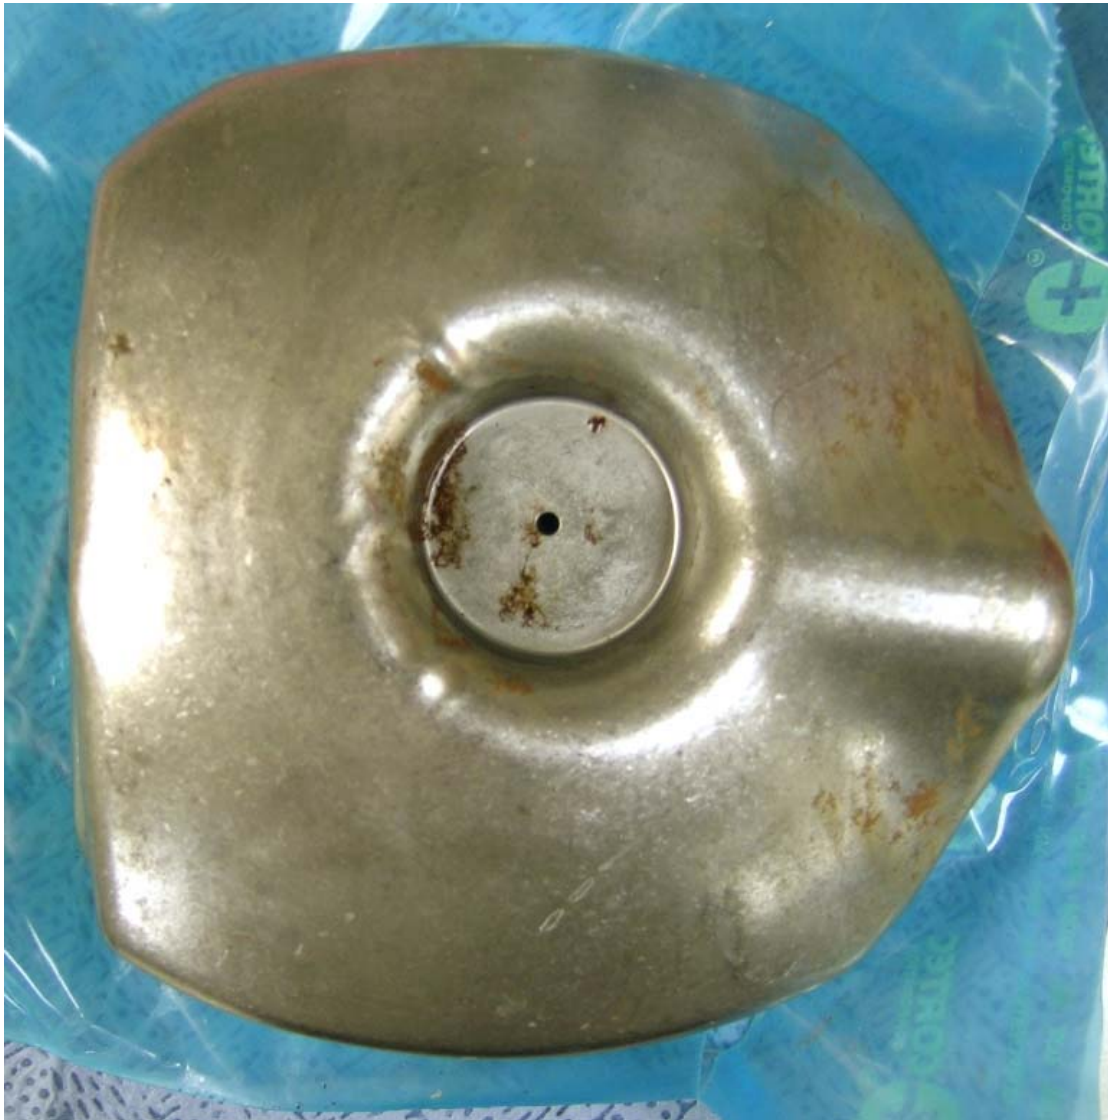
Figure 2: Metal stamping, wrapped in VpCI-126 blue film, after 840 hours of humidity testing.
