***Corrosion Testing of Different Liquid  
Rust Preventatives on Metal Cans***

**Project #:** 13-122-1825.bis

**Method:** ASTM D-1735 (Water Fog Test)

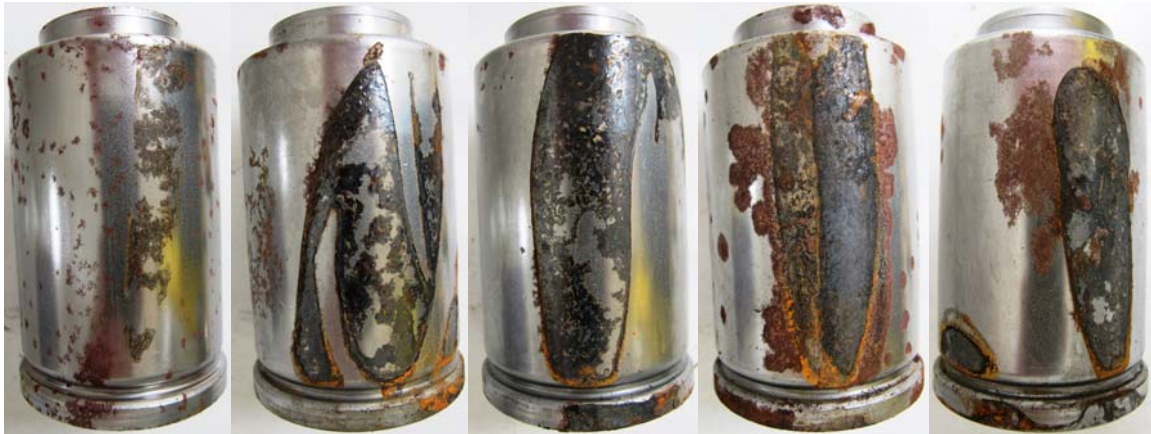
**Photos:** Taken after 408 hours of humidity testing

Control      Tuf Draw      Tuf Draw + M-250      Pro Draw      Pro Draw + M-250

The results show that adding M-250 only marginally improved the corrosion protection of the soluble oils. BioCorr is also an emulsified oil, but provided significantly better corrosion protection than either the Pro Draw or Tuf Draw. The corrosion seen on the cans coated in these products is worse than the control. After each part reached corrosion failure, areas of severe corrosion quickly formed, especially where the polyethylene bag contacted the can.

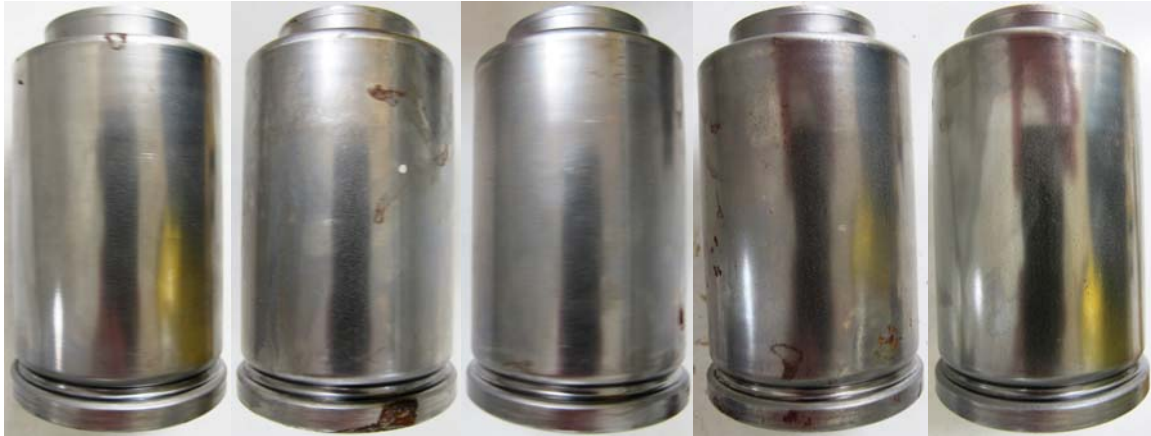
BioCorr      VpCI-377 (5%)      VpCI-377 (10%)      RP-7 (5%)      RP-7 (21%)

The rust preventatives compared to Beaver RP-7 all showed good corrosion protection. The best protection was provided by RP-7 at 21%; however, this is a much higher dilution than typically used for water based rust preventatives. This dilution was only used because the customer titration chart called for a dilution of 21%  $\pm$  2%. BioCorr and VpCI-377 at 10% both provided very good corrosion protection and did not fail until after 400 hours.
