Evaluating VpCI-126 Film for Customer

Project #: 13-202-1125.bis

Date: November 12, 2013

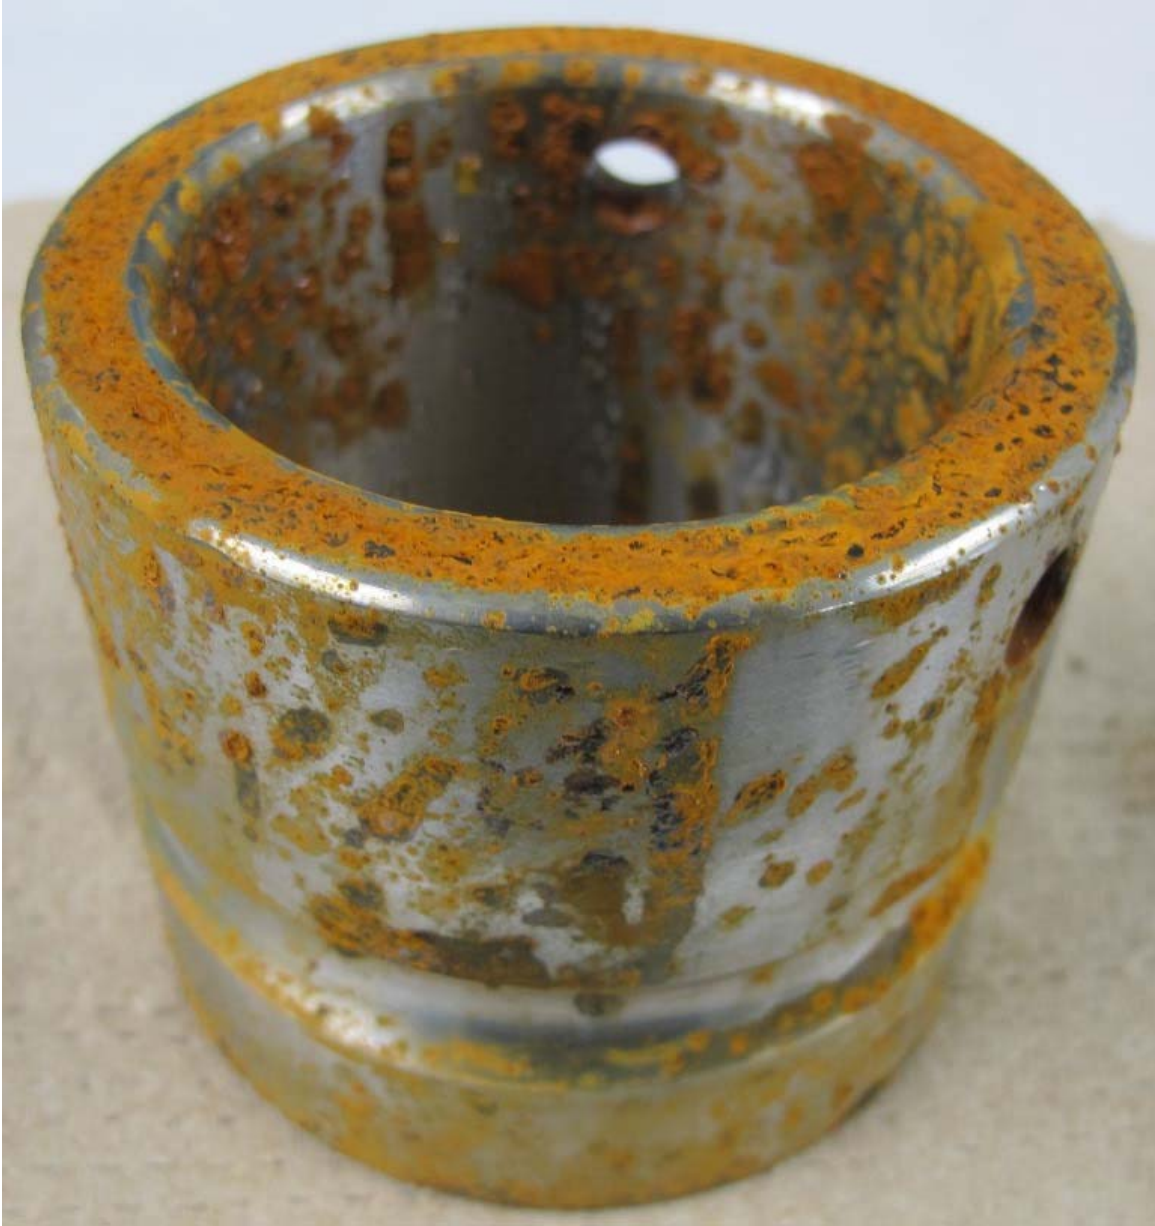
Figure 1: Non-VCI PE packed part, after 504 hours in ASTM D-1735 testing.

Packaging Used	Time to Corrosion (Hours)
Non-VCI Polyethylene	24
VpCI-126	504

Interpretations: After 504 hours in ASTM D-1735 water fog testing, VpCI-126 provided excellent corrosion protection, when compared to a non-VCI polyethylene film.

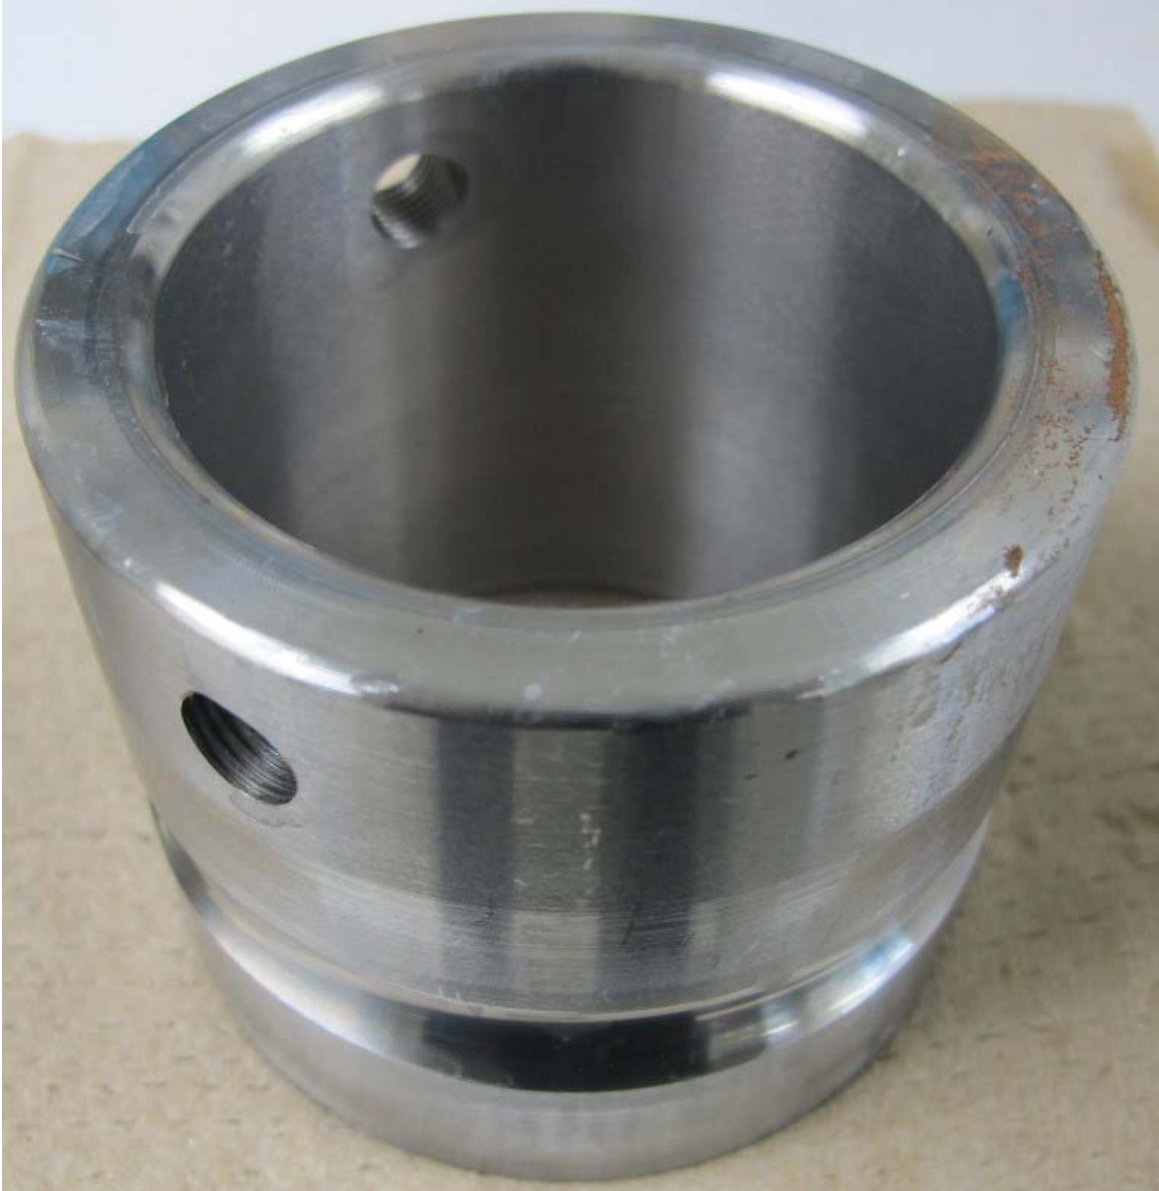
Figure 2: VpCI-126 packed part, after 504 hours in ASTM D-1735 testing.
