Evaluating Rust Preventive Liquids on Sintered Metal Parts

Project #: 14-037-1825.bis

Date: March 24, 2014

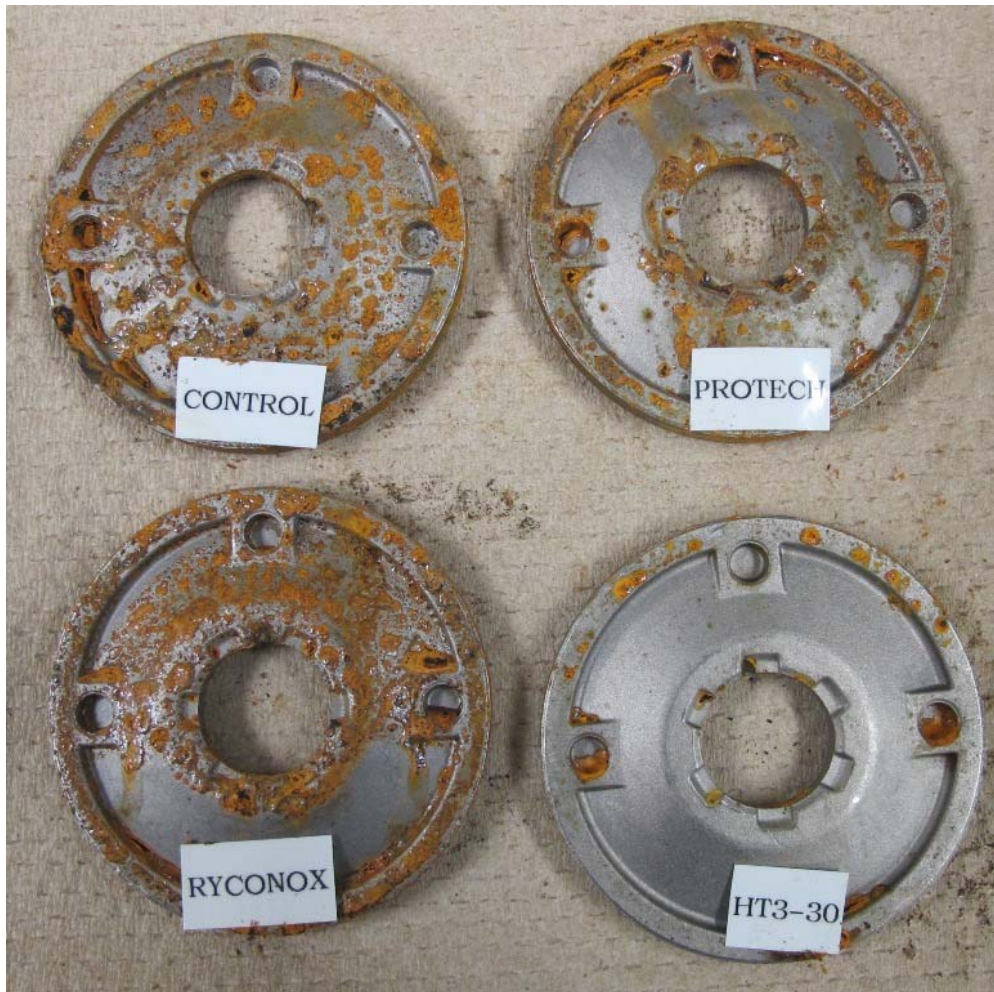
Figure 1: Four sintered metal rings, after 168 hours of ASTM D-1735 testing. The three rust preventives currently used by Customer were used in this group.

Rust Preventive Used	Time to Corrosion (Hours)
None (control)	<8
Chemetall Protech P440CA	24
Oakite Ryconox 20M	24
HT3-30	72
VpCI-325	96
VpCI-329D	72
BioCorr	72
BioCorr SC @ 25%	168*
EcoLine 3220	168*

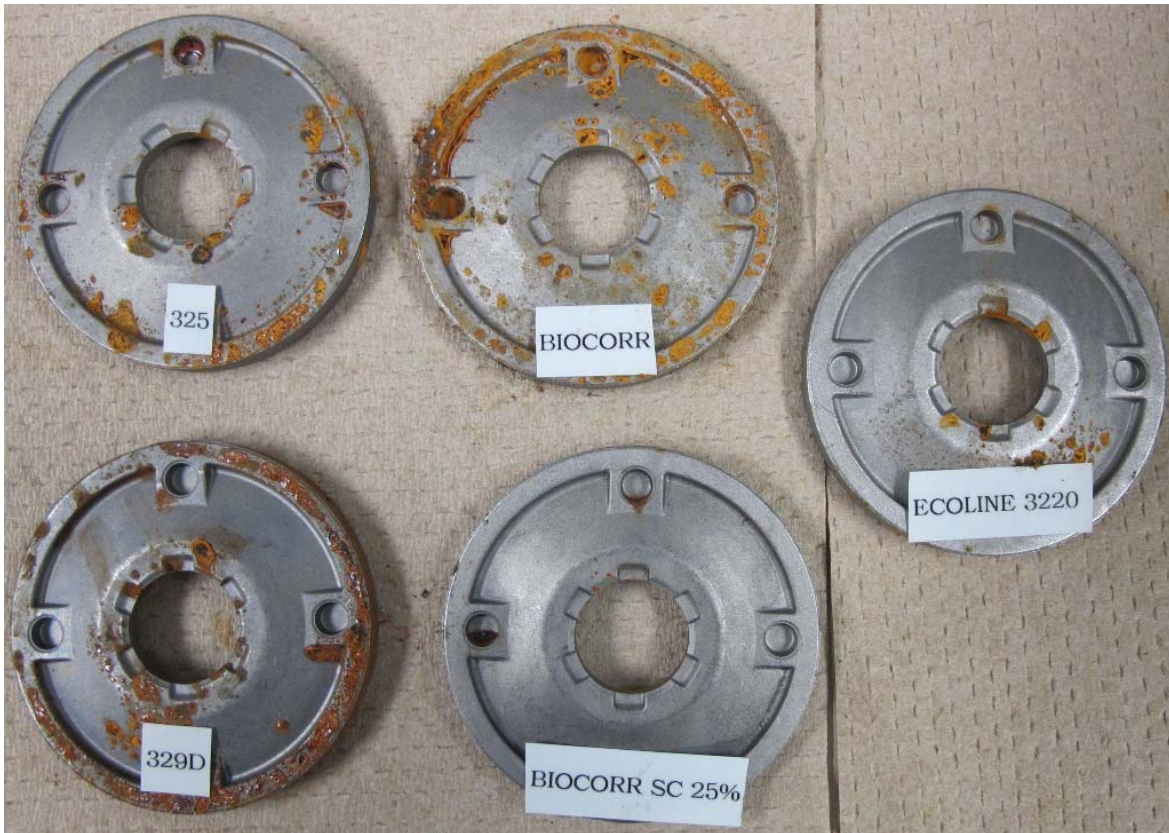
Figure 2: Five sintered metal rings, after 168 hours in ASTM D-1735 testing. The five Cortec rust preventive options were used in this group.

After 168 hours of ASTM D-1735 testing, the best corrosion protection was provided by BioCorr SC (used at 25% concentration by weight), and EcoLine 3220. The two rings coated with these products were corrosion free after 106 hours of testing, and corroded slightly upon the next inspection, at 168 hours, after the weekend.
